OPEN SPACE CONDITION ASSESSMENT

**Little Stanion Farm Management
Company**

Little Stanion, Corby

Ref: 15-3182

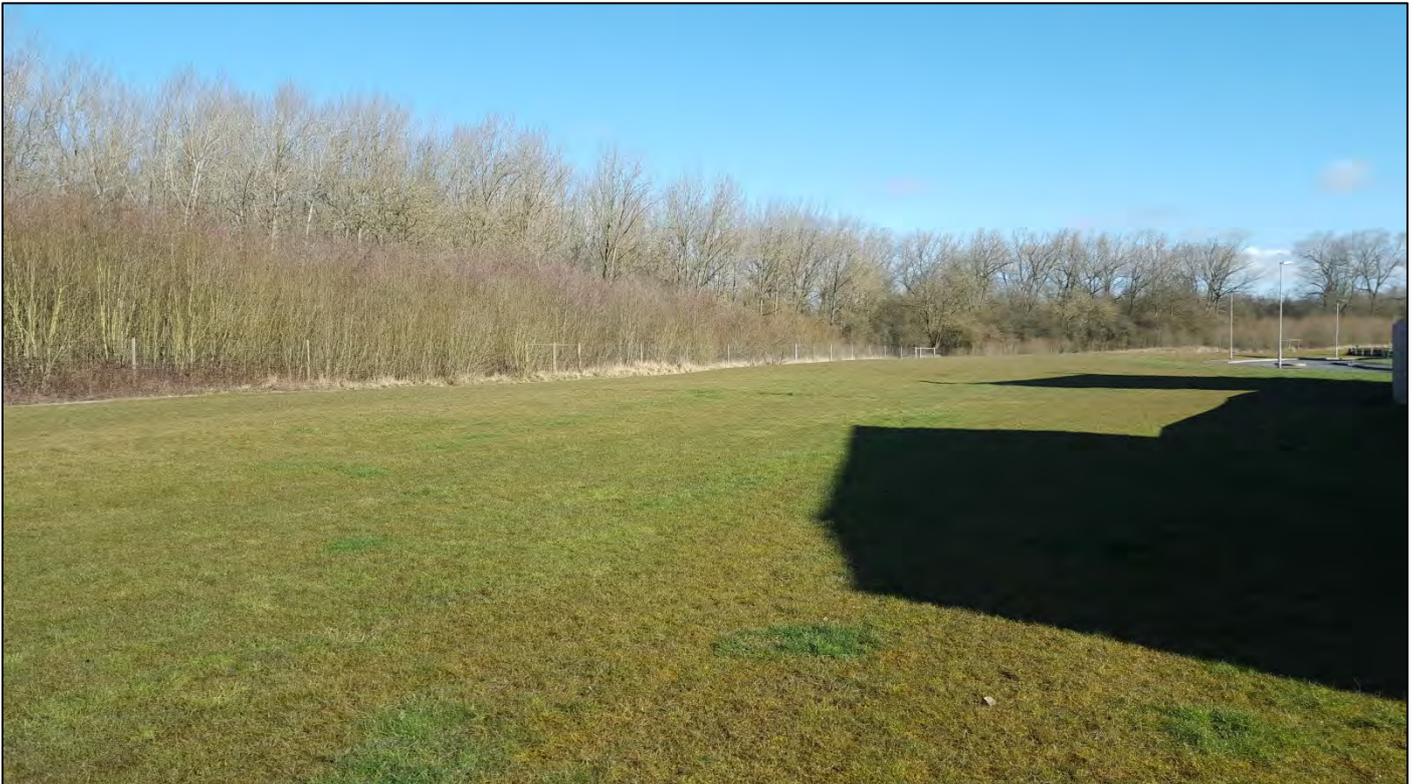
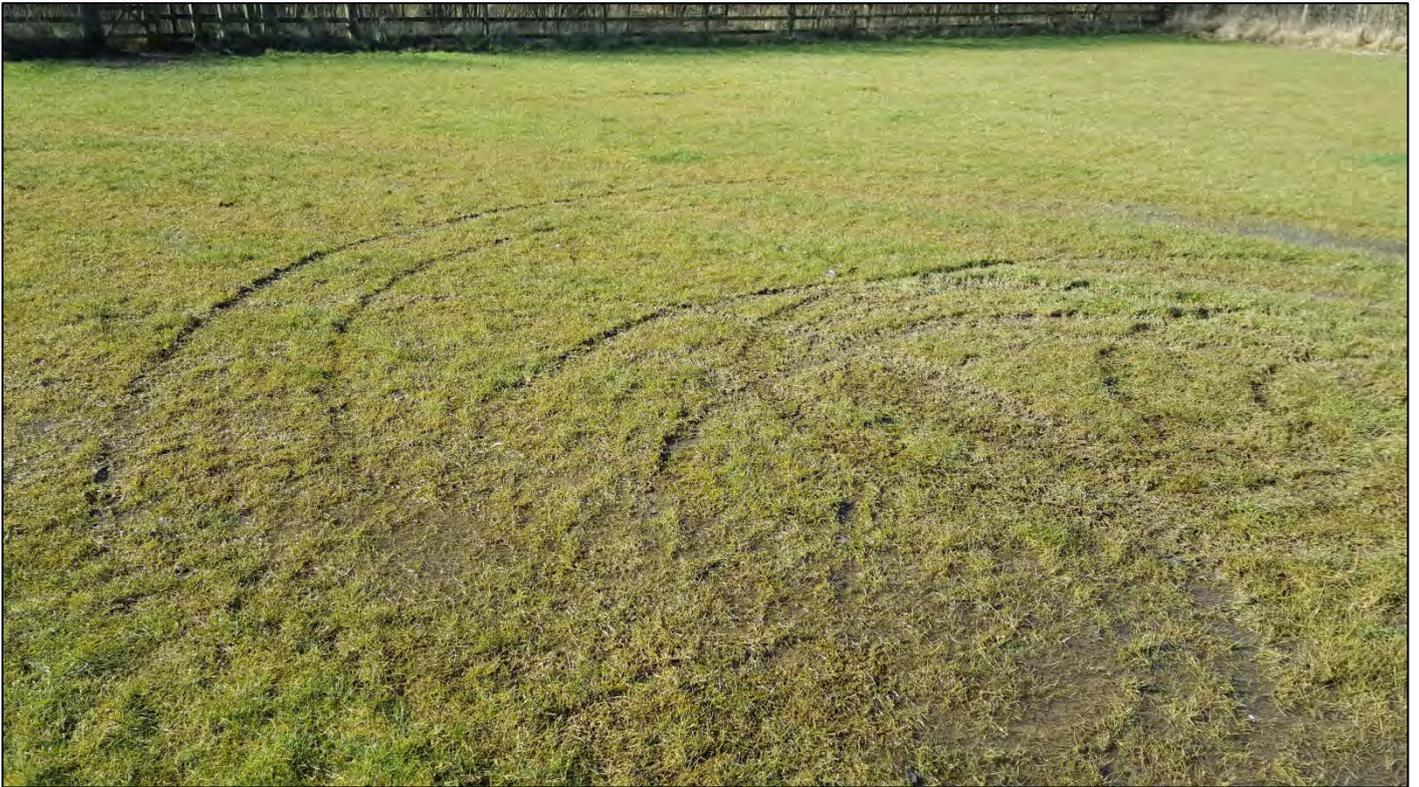
- 2.3. The grass sward is fully established with minimal broadleaf weeds present.
- 2.4. It is currently wet underfoot, which accounts for the fact that it is yet to receive the first cut of the growing season. Some minor damage was noted, likely caused by a motorcycle tracking through the area in wet conditions. The damage is minor but should be monitored for signs that compaction is impeding growth performance.

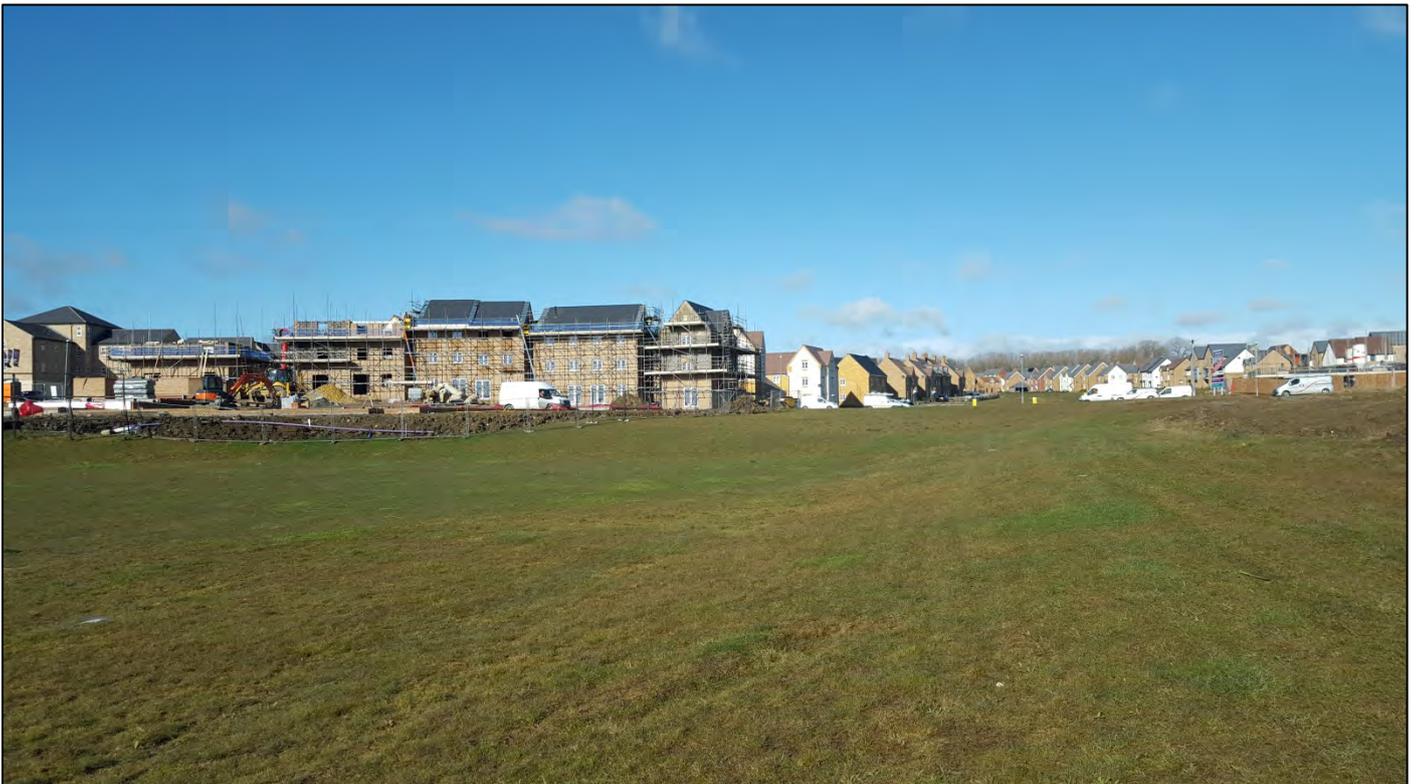
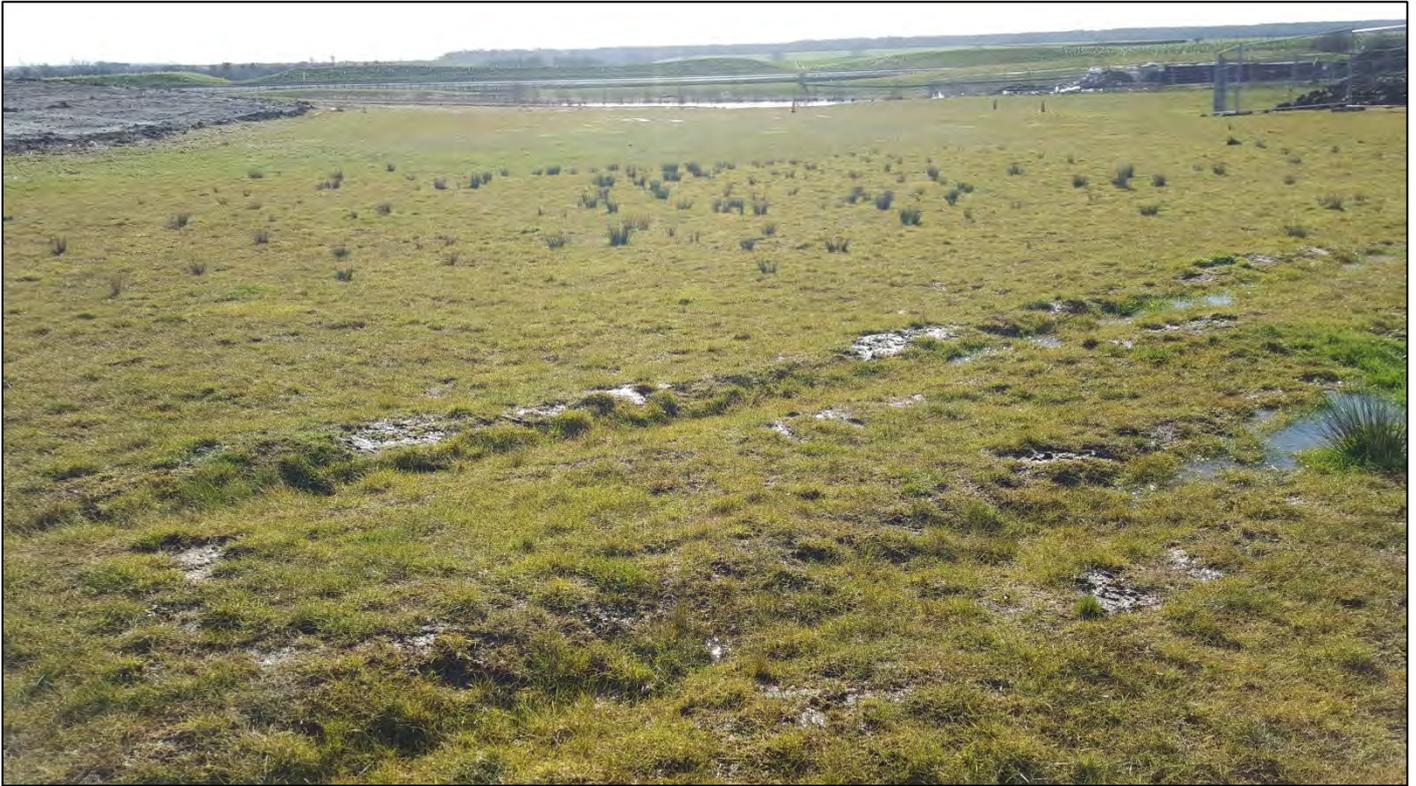
- 3.3. The amenity grassland areas are generally well established with very little weed growth observed; however the wet winter has encouraged the establishment of rushes within the amenity areas, in particular at the lower end of Long Meadow within the levelled playing field. Whilst the presence of a minor element of rush in the main meadow sward is acceptable, it is recommended that the rushes in the playing field area be controlled through the targeted application of herbicide using a weed wiper or similar.
- 3.4. Some vehicle tracking has occurred at the lower end of Long Meadow. At the time of surveying these tracks held standing water. This highlights the fact that any attempt to cut the amenity grass would likely cause further damage by the machinery, and therefore this activity should be delayed until ground conditions improve.

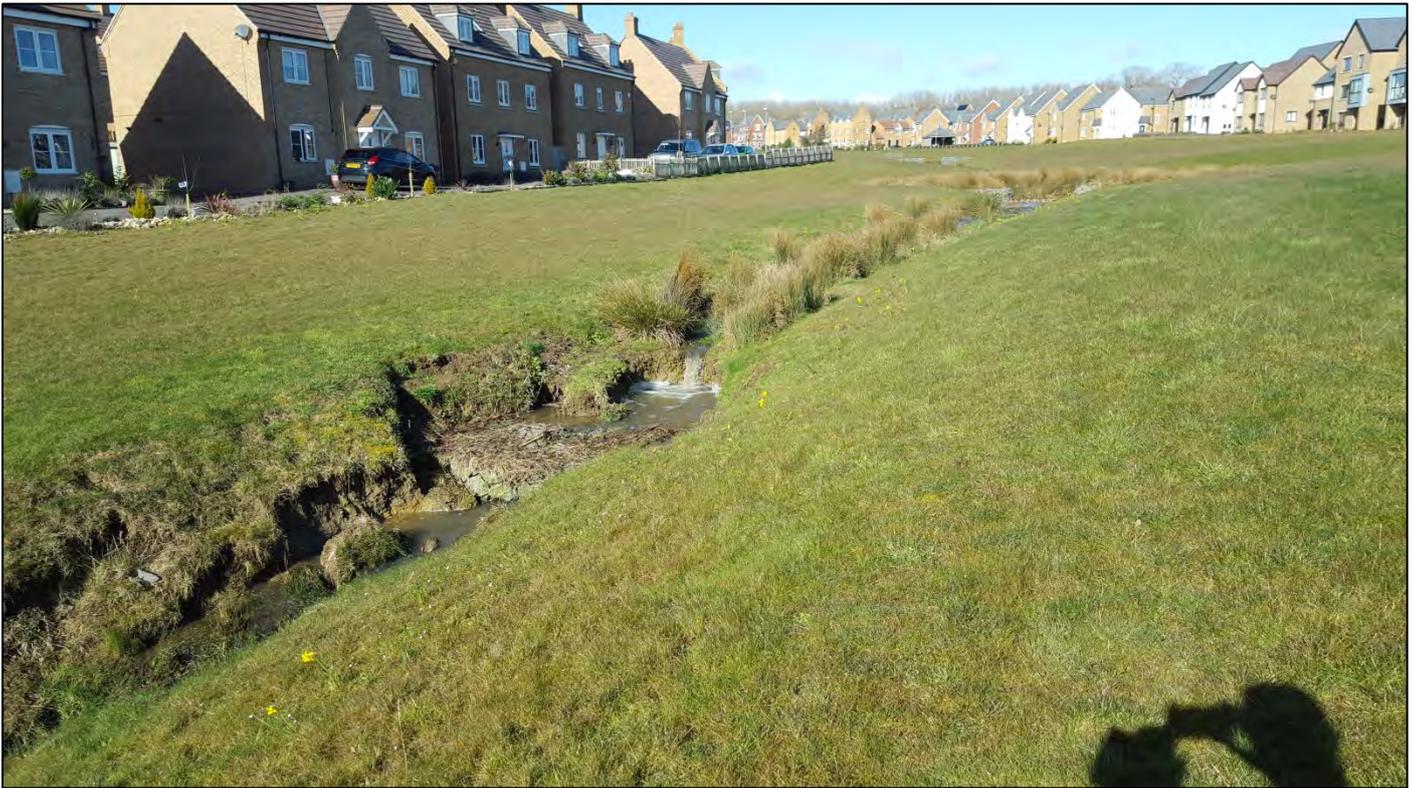
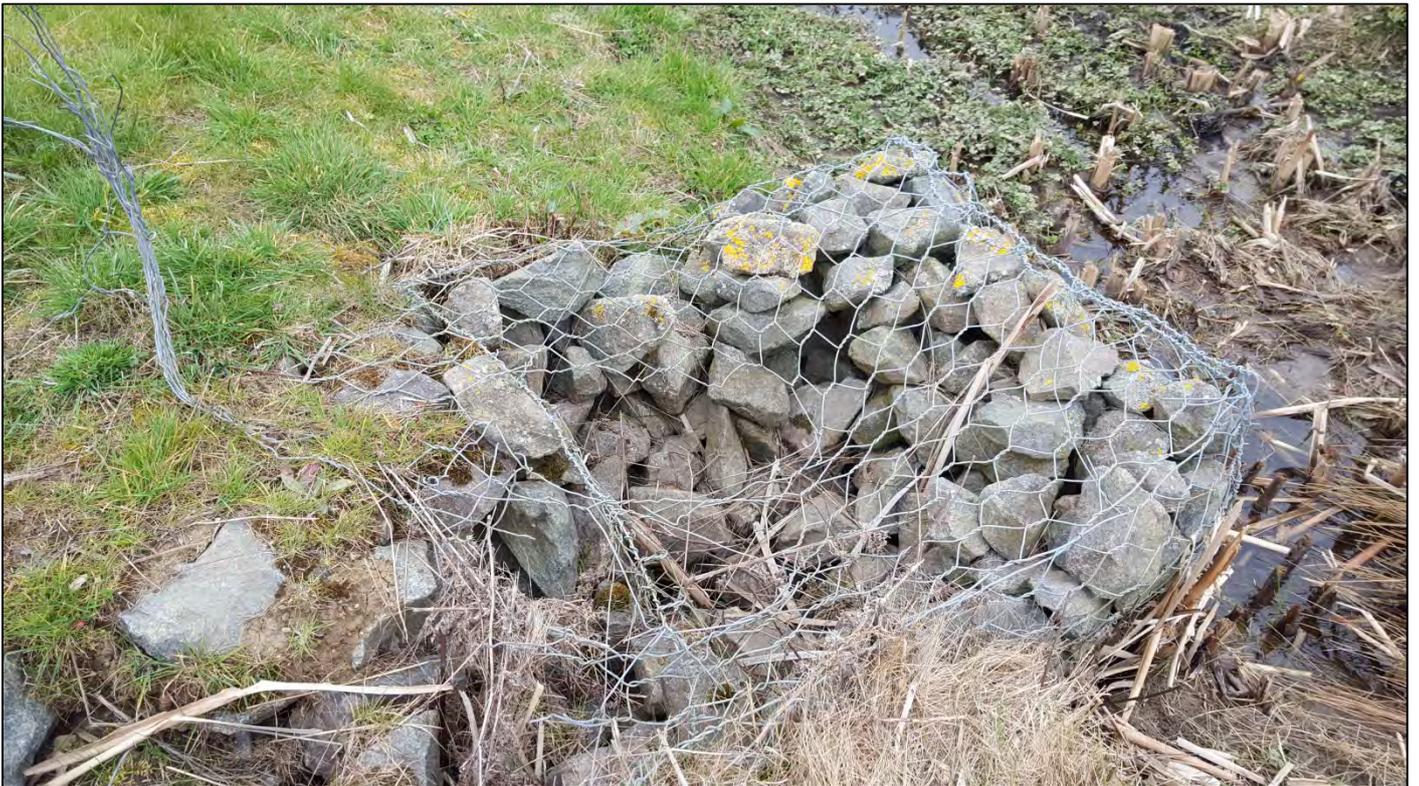
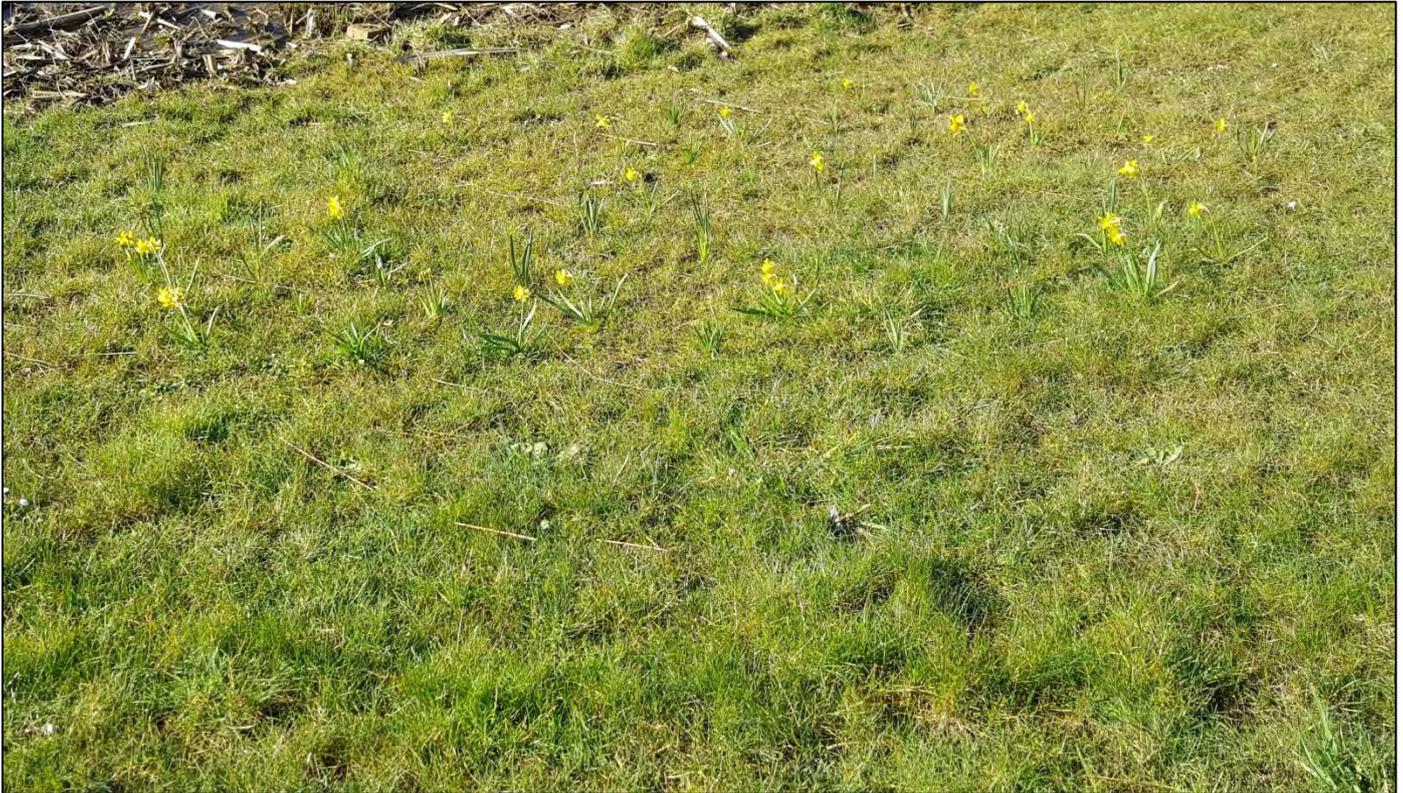
- 3.7. The swale which forms the spine of Long Meadow is well established with a range of aquatic and marginal species which are growing strongly. The channel itself has been reformed by the passage of water into a more natural appearance.

- 3.8. There are woody species (willow and dogwood) colonising the swales, particularly at the top of Long Meadow. Any goat willow should be cut and treated with herbicide to prevent further establishment.

- 3.9. One of the gabion cages, which form a vital function within the swale, has been vandalised and some of the stones removed. It is recommended that this is monitored regularly and if this behaviour persists steps should be taken.

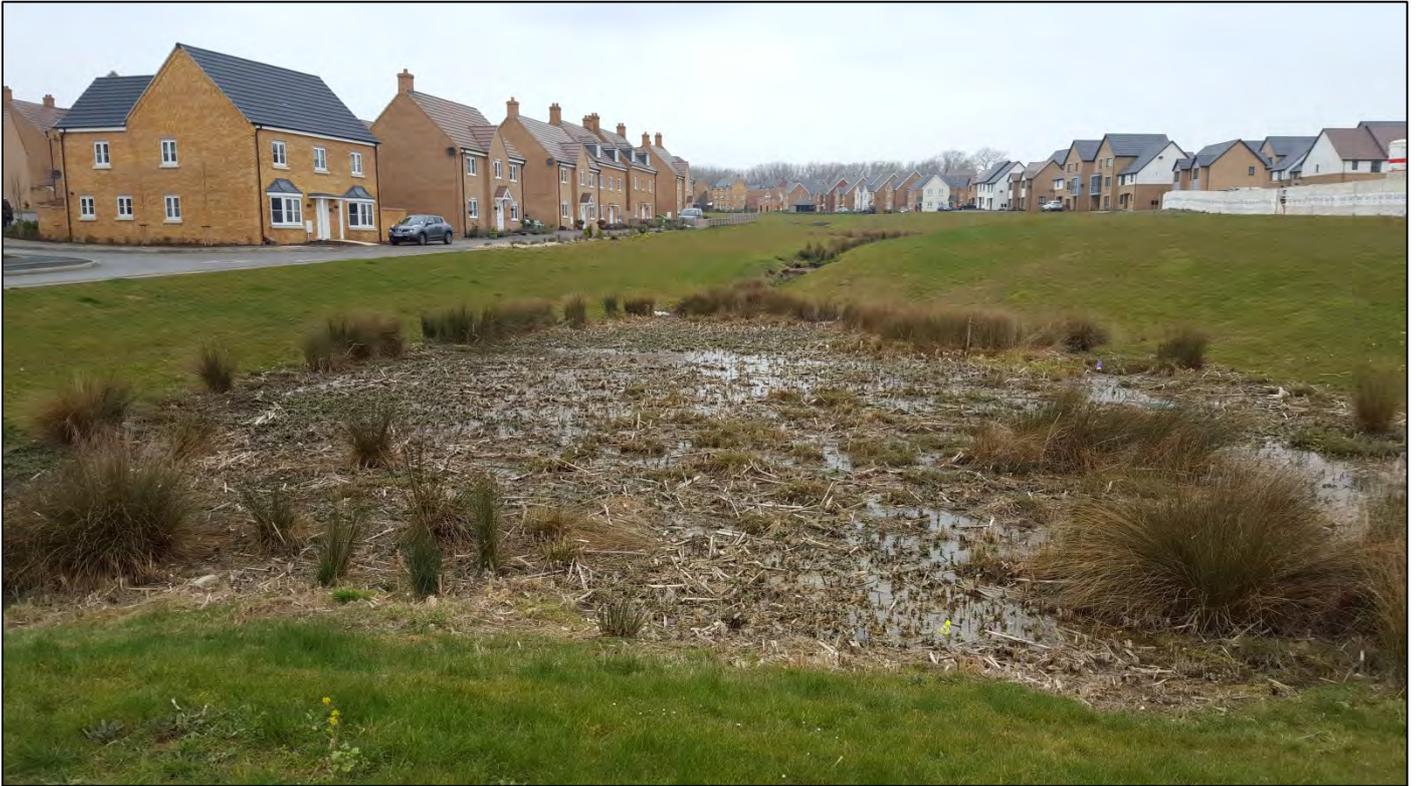
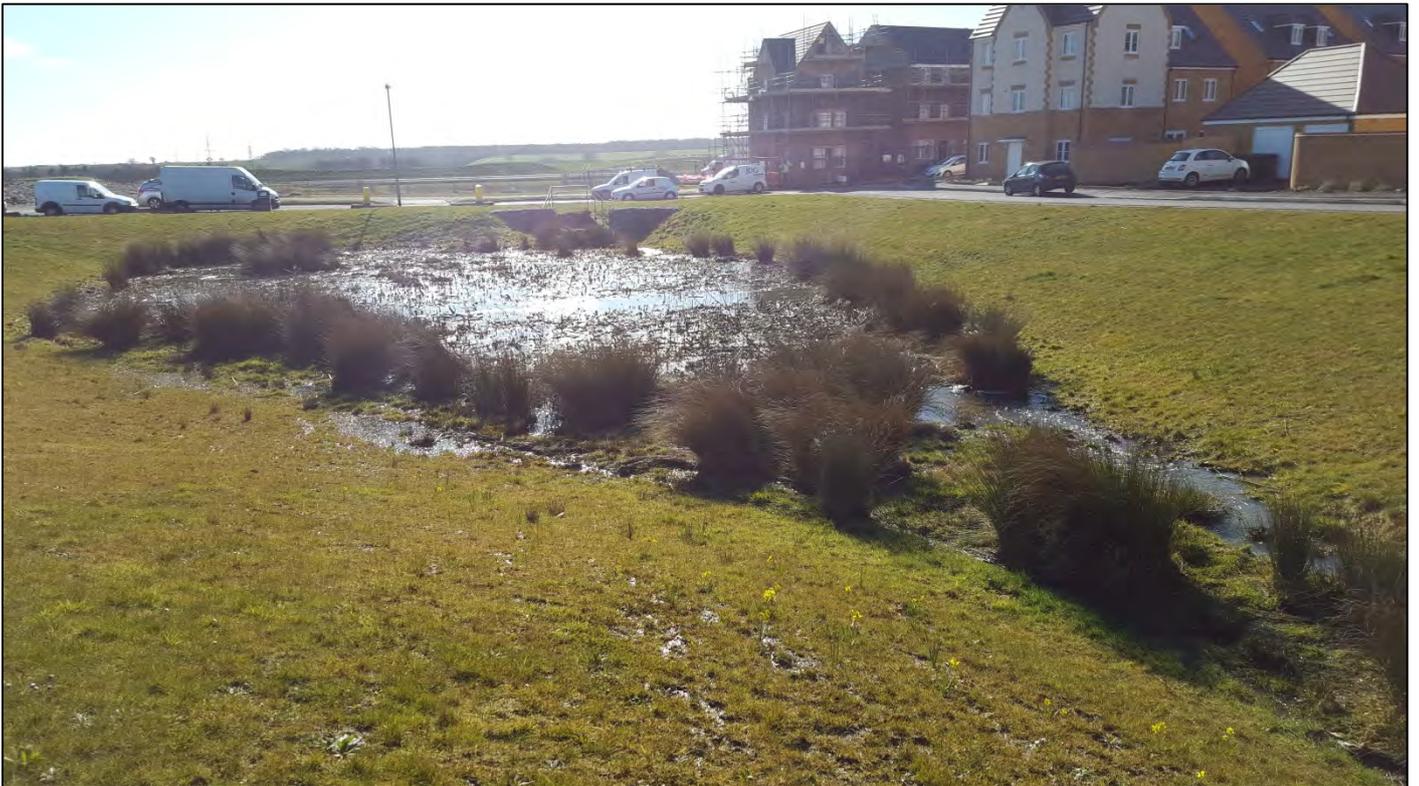
- 3.12. These holding basins are designed to attenuate water flow and reduce flooding in severe weather events. These basins have been thoroughly tested over the winter, and are clearly performing well at reducing flooding of the lake.
- 3.13. Over the winter months they have received management to reduce the invasive common reed *Phragmites australis* which would otherwise smother the areas and out-compete other wetland species. Evidence of new growth is already evident within these basins.
- 3.14. The reeds grow and spread very quickly, and it is common practice to cut them down to the rootstock every other winter.

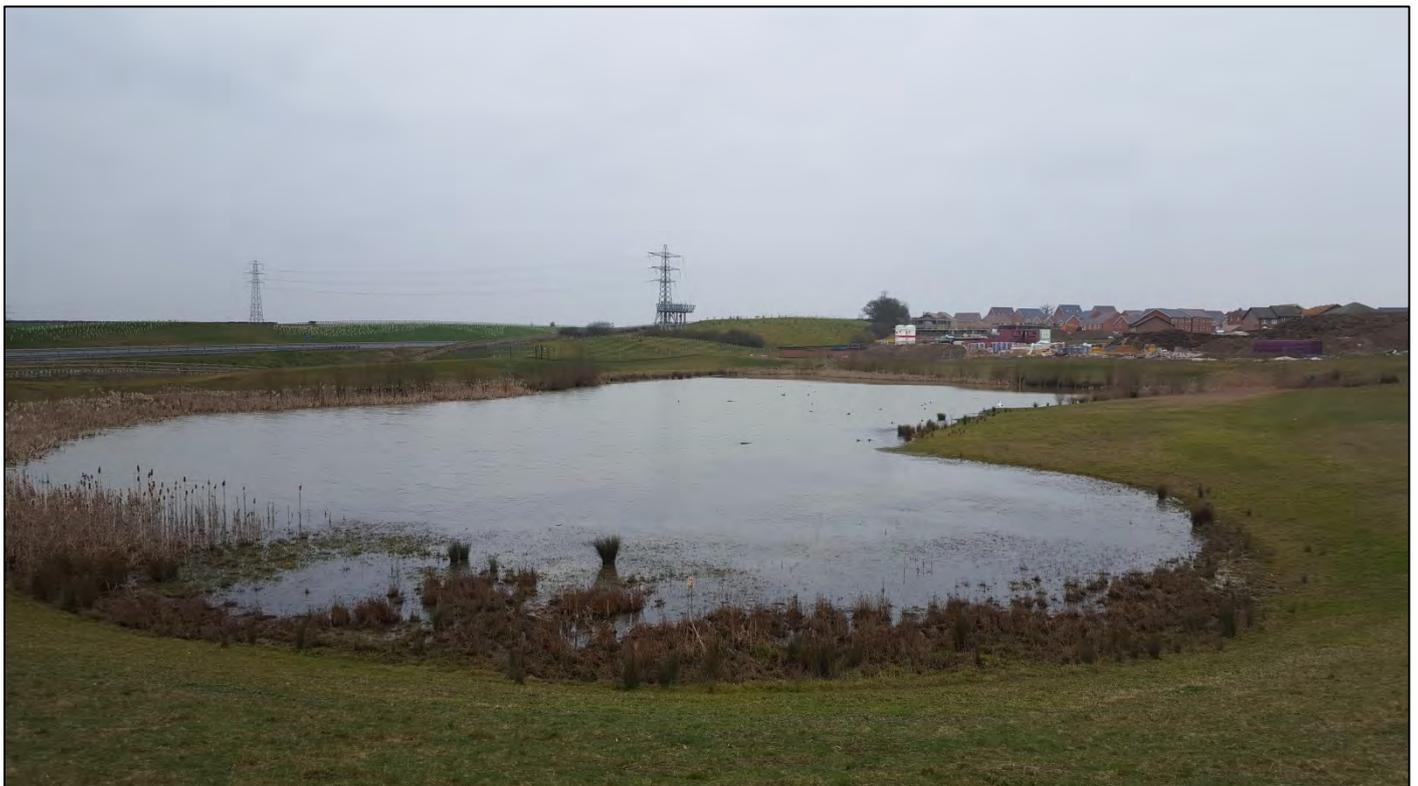
- 3.15. The lake is looking well-established, with reed and rush beds and clumps of willow at the water's edge, all of which are helping to encourage overwintering birds. Minimal litter was observed.

- 3.16. It was too early in the season to accurately identify the species of willow, however it would be advisable to remove any goat willow in the first instance, as this is a far less desirable species. Not more than one third of the waterline should be allowed to be colonised by willow species, which grow very quickly and can cause problems associated with leaf drop and over-shading.

- 3.21. A post and rail fence runs between the lake and the A43. This is generally in good order, although a small number of horizontal rails have been broken.

- 3.22. Long Meadow was generally litter-free, although a small amount had collected within attenuation basins and outlets.

- 3.17. It is recommended that the willow colonisation is reviewed in the Autumn of 2016 to determine if coppicing should commence.
- 3.18. It is recommended that around 20% of the willows are coppiced, in small groups, every 5 years. Goat willow stumps should be treated to discourage regrowth.

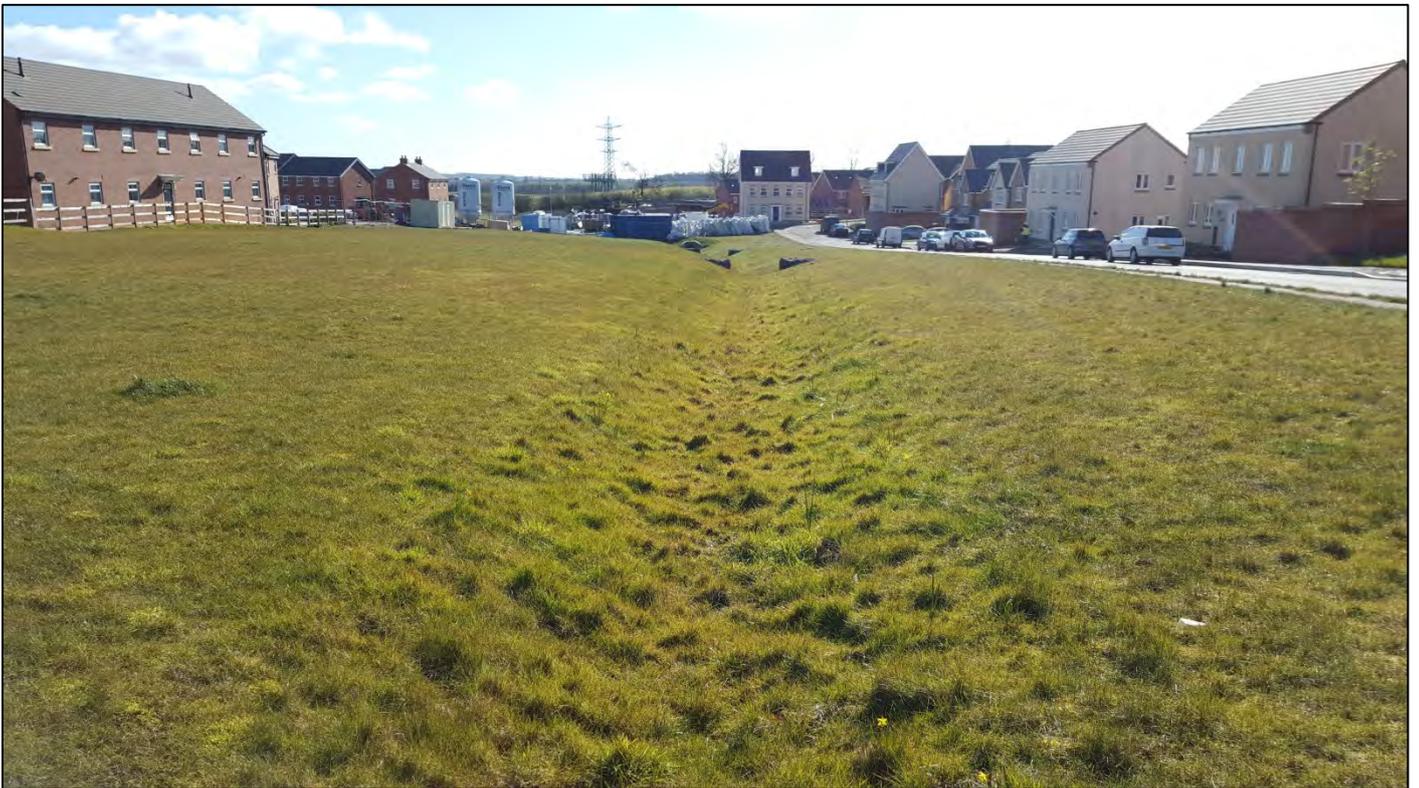
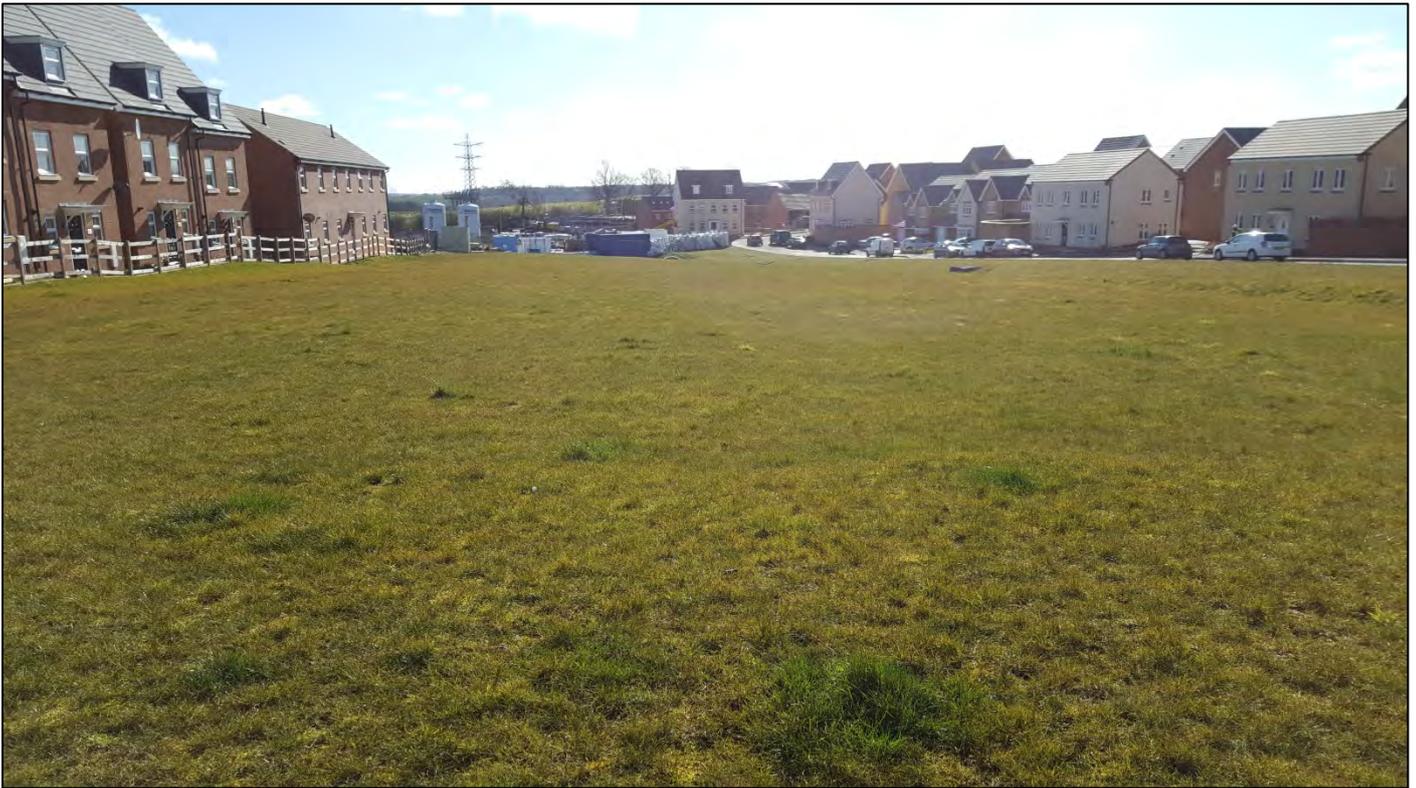
- 4.3. As with elsewhere on site the grass is yet to be mown for the first time this year; however it is well-established and relatively weed-free.

- 4.4. The swale appears as little more than a linear depression within the grass, with gabion cages stacked at the outfall and intermittently along the length. No standing/flowing water was present at the surface.

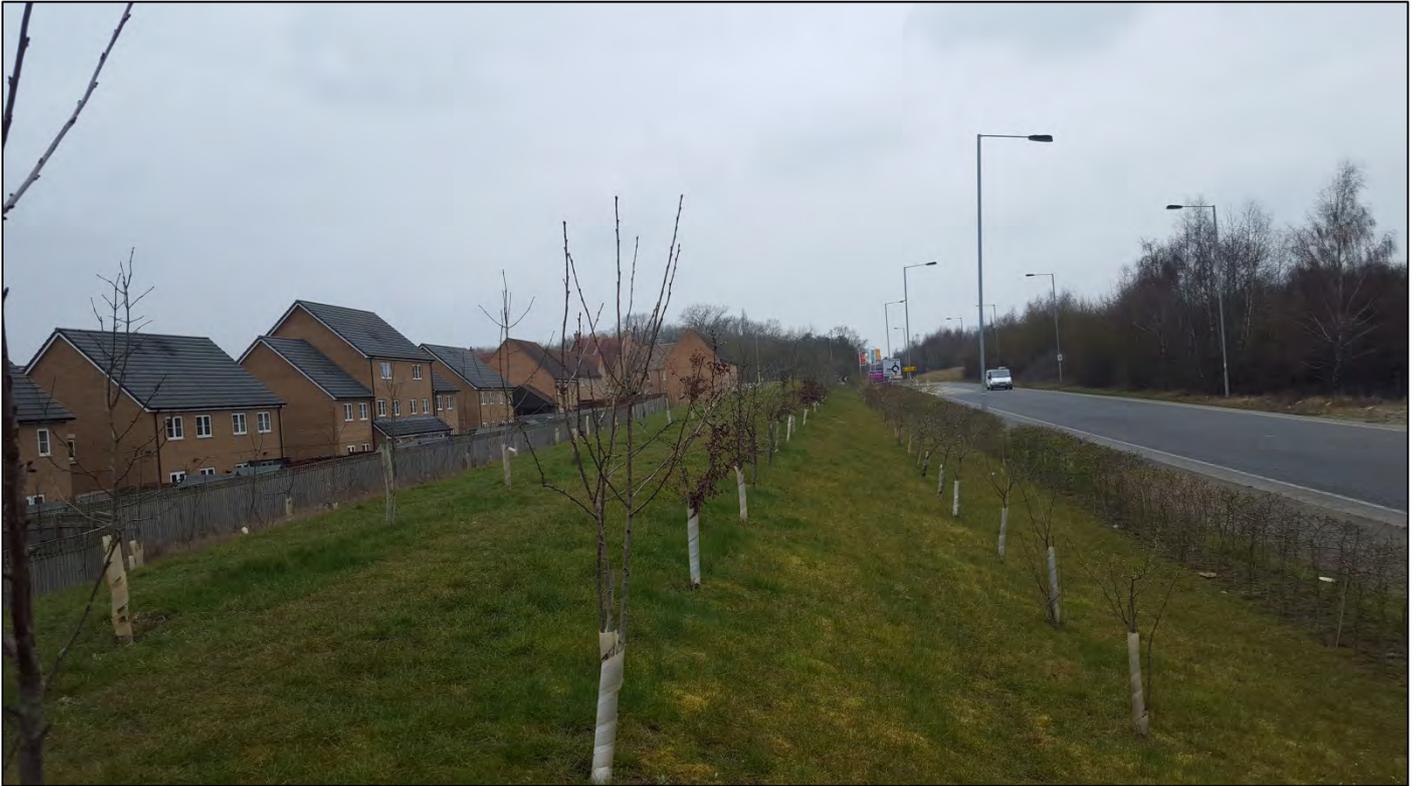
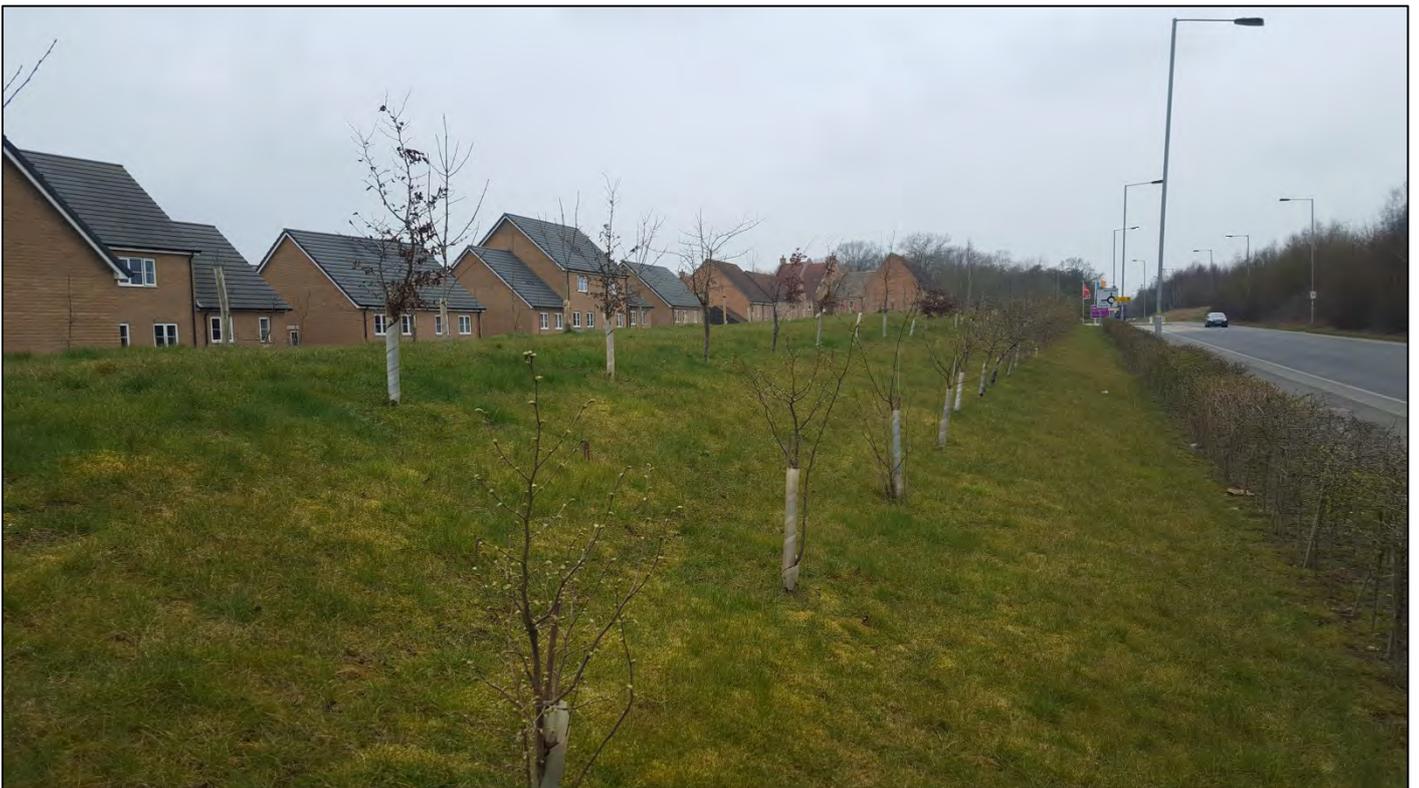
- 5.3. The trees and shrubs are well-established with heights between one and three metres depending upon species, and are showing good spring bud formation. Mammal protective guards and supports are in good condition, generally free of leaf debris and soil.
- 5.4. Significant deer tracks were noted in this area; it is therefore advised to leave the guards in place.
- 5.5. The grass sward is yet to receive the first annual cut due to the weather conditions, however it is well-established and generally free of broadleaf weeds.

- 5.6. The hedgerow plants have had their guards removed, and appear to be left alone by the deer community. The hedge has been regularly topped, and is starting to knit together to become an established hedge.

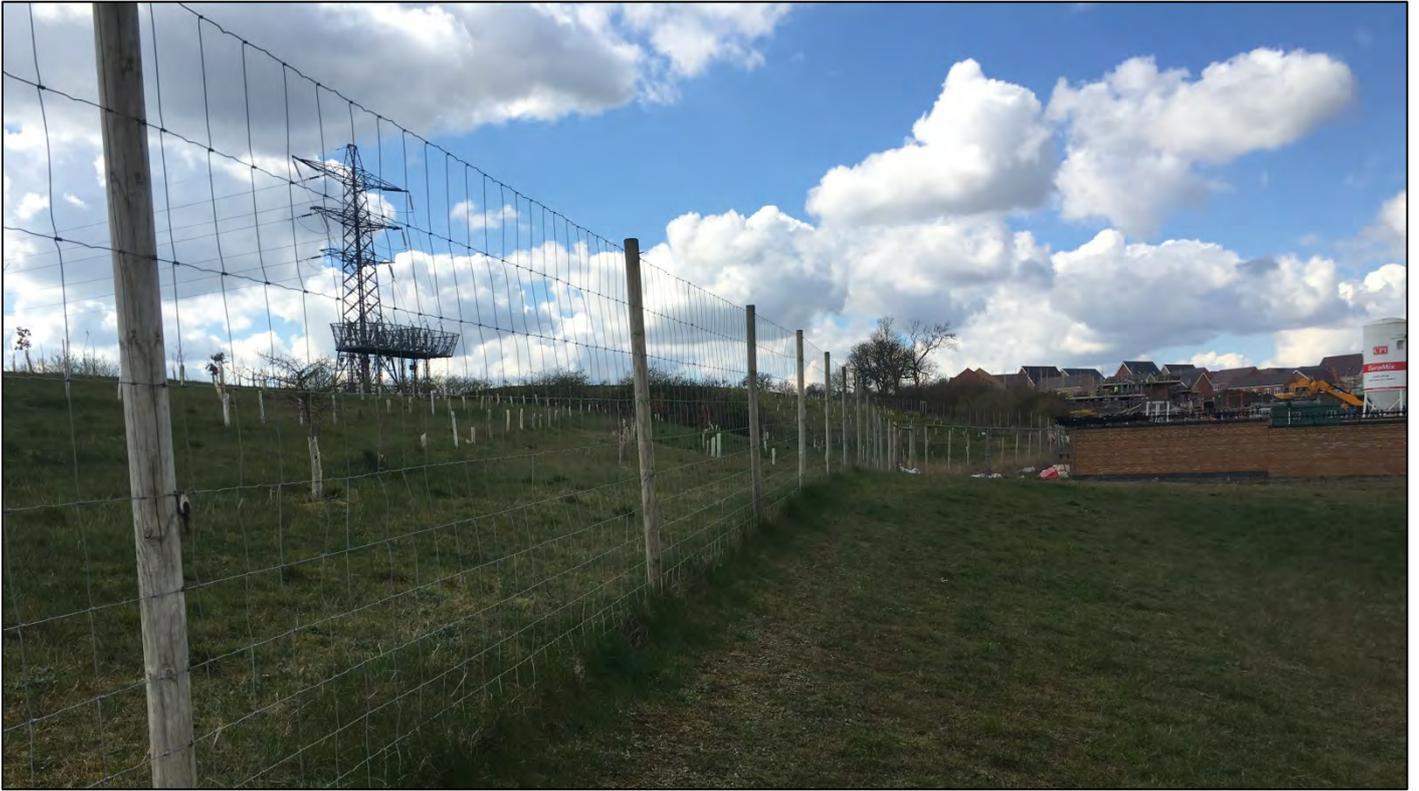
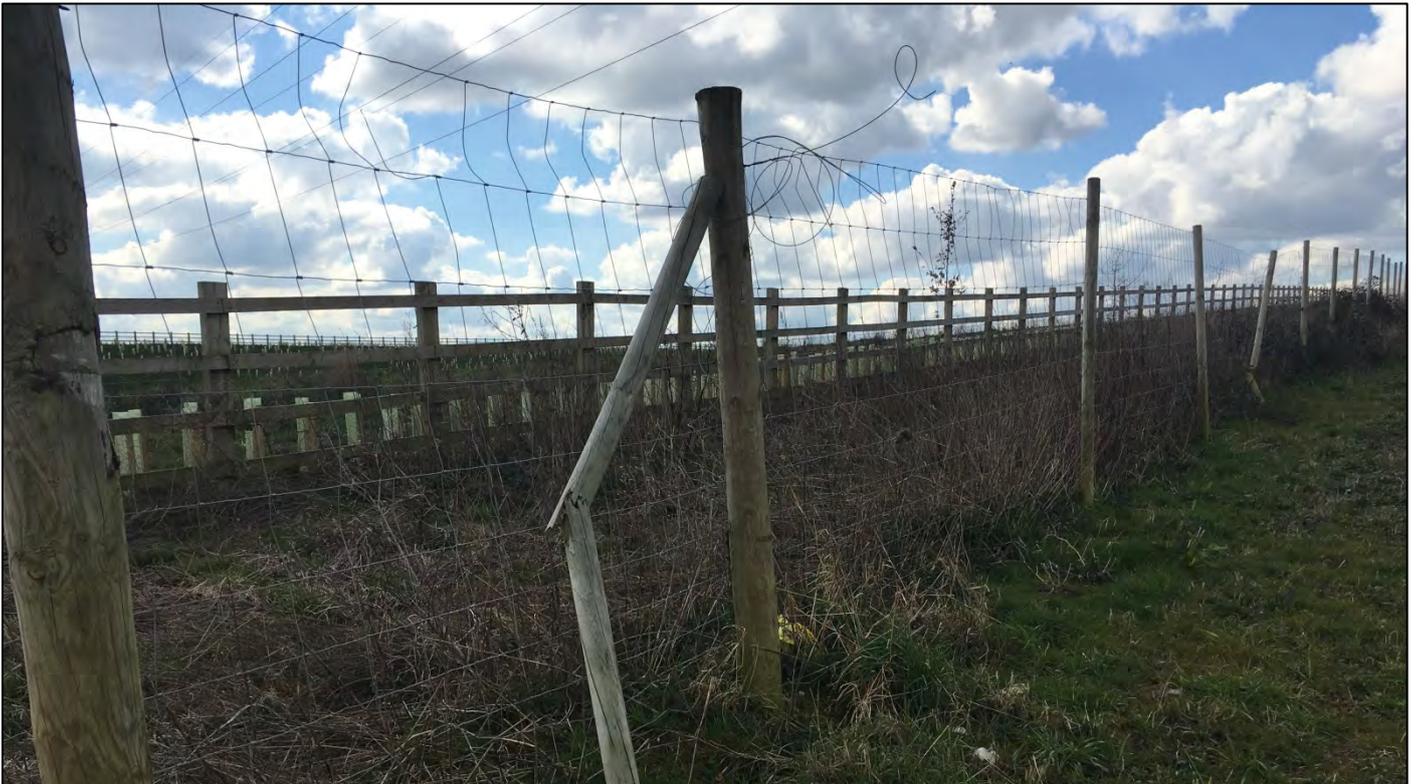
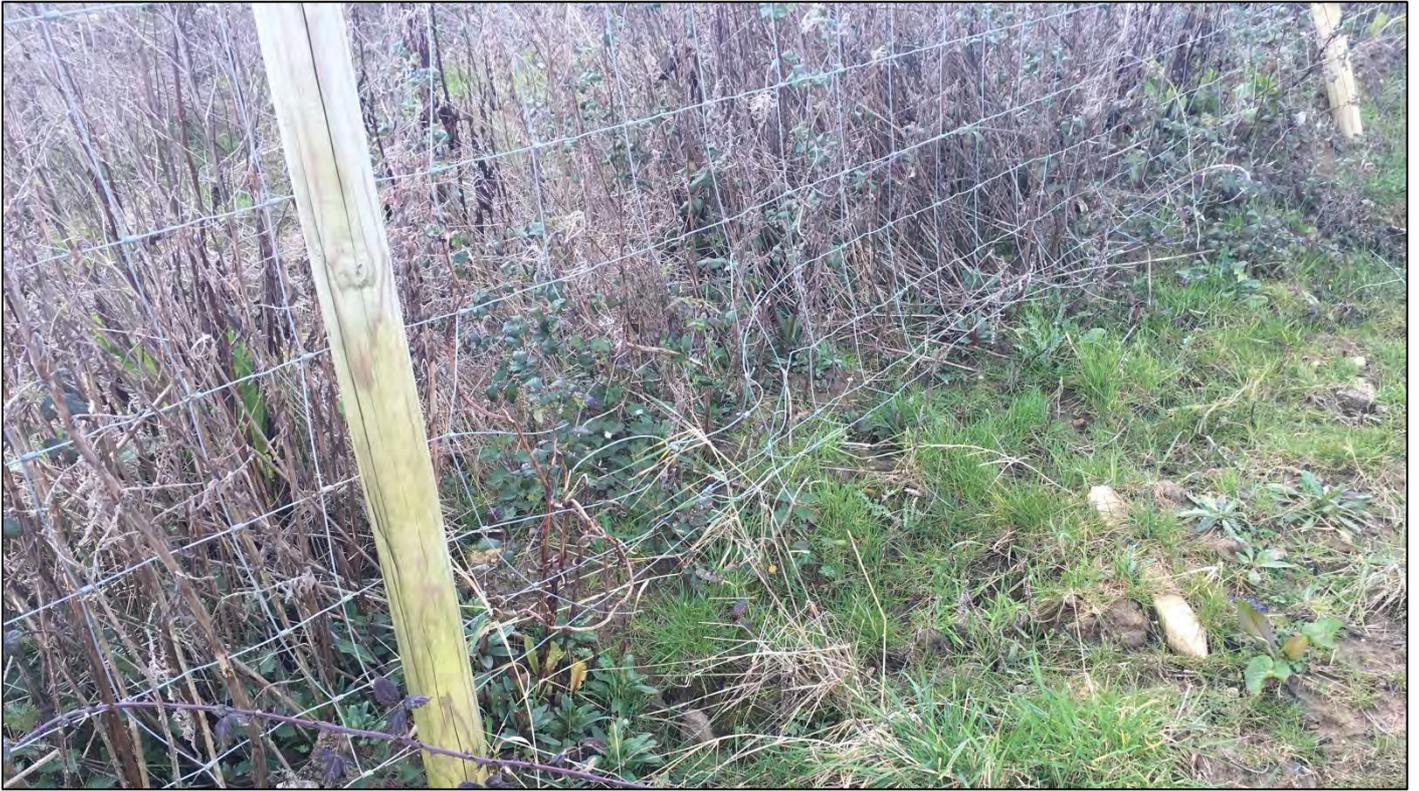
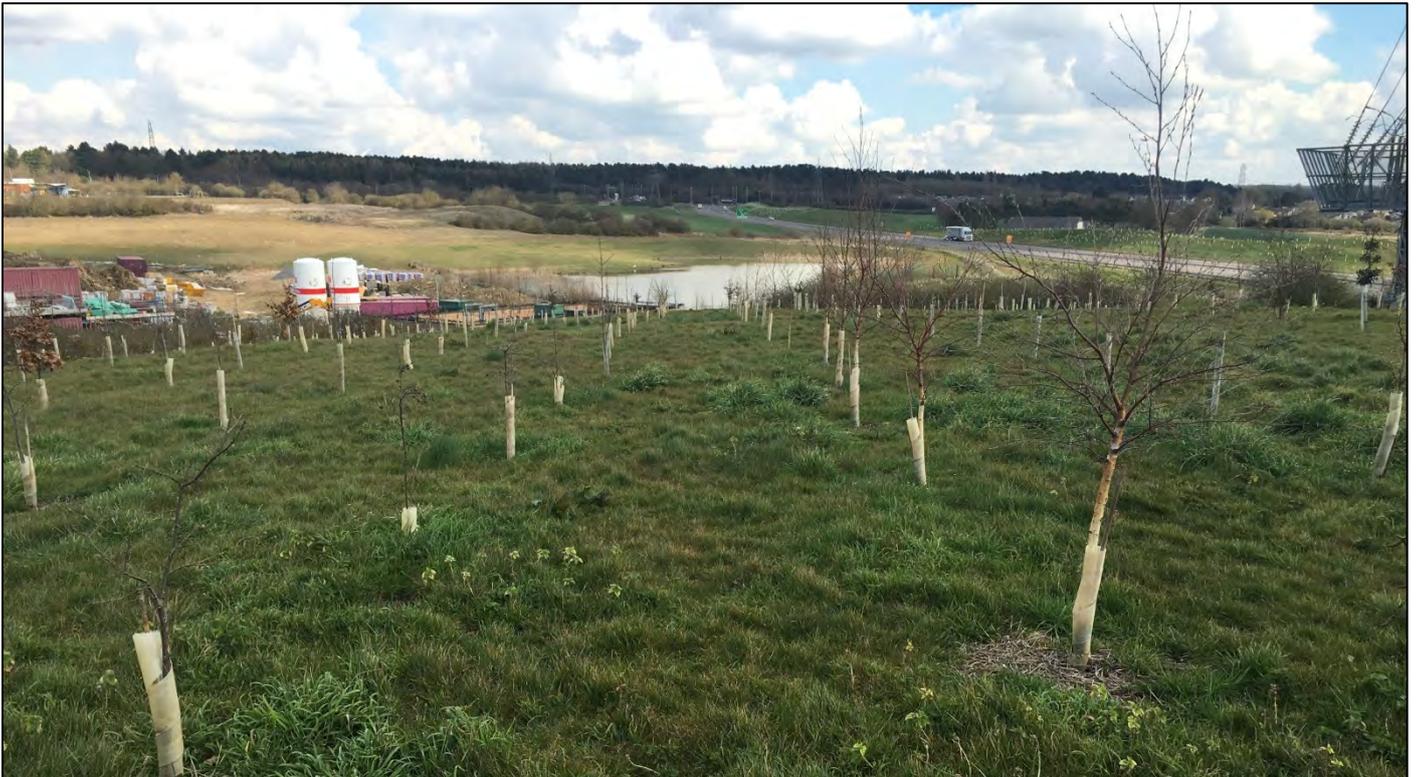
- 6.5. The trees are growing well, with good bud growth present on a random selection of plants inspected. Some recent replanting has occurred around the pylon. Mammal guards and supports are generally in good condition.
- 6.6. The grass is not competing with the trees, presumably through herbicide management, and guards were generally free of leaf litter and soil.

- 6.7. The path is well established and well-used. At the time of surveying it was clear of any trip hazards and vegetation; an area of mud was present around the break in the hedge line.

- 6.8. The deer fence is generally in good order, with the exception of two broken posts on the run between the woodland and the A43. The straining wire has also been cut, and should be repaired to secure the longevity of the fence.

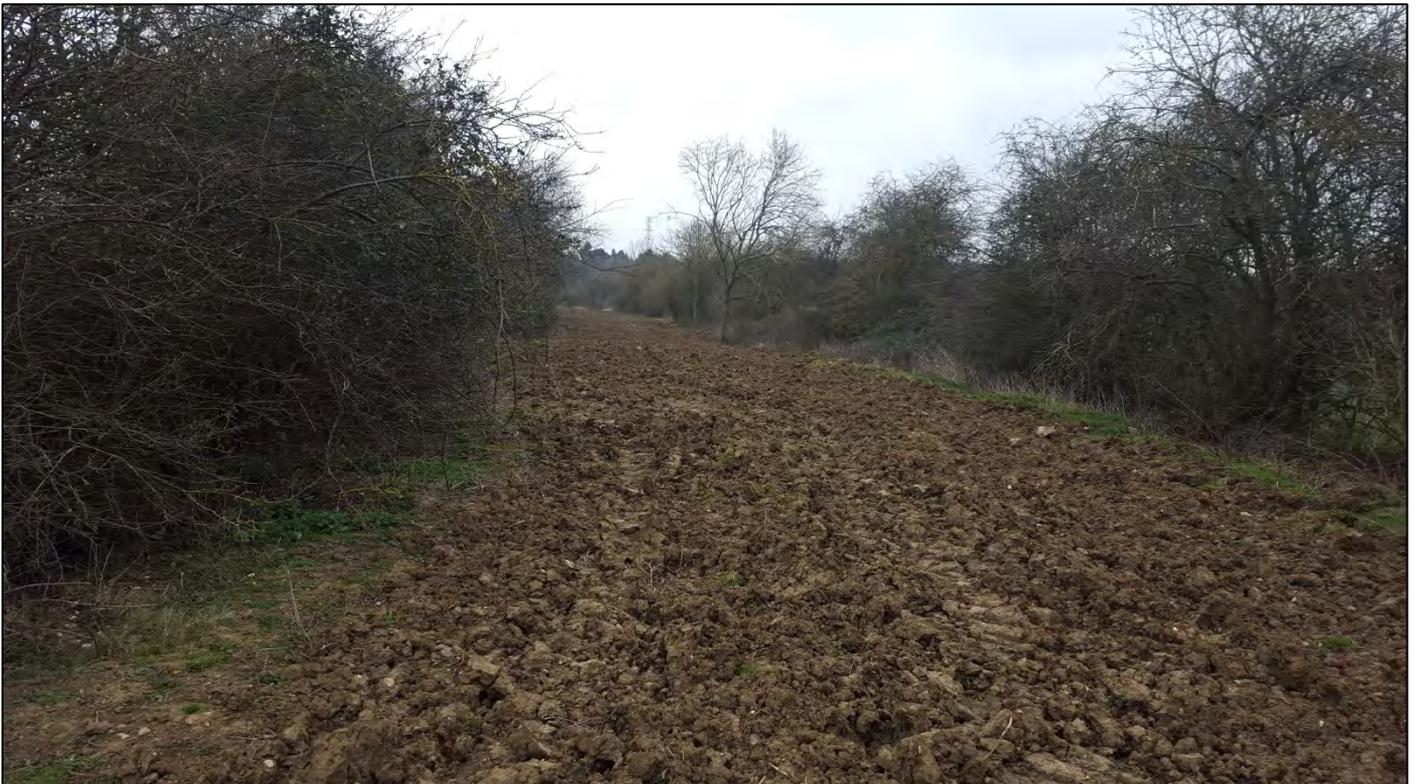
- 7.3. It appears that measures have been undertaken to commence remediation of this area following excessive damage caused by vehicle tracking in sub-optimal ground conditions.
- 7.4. It is assumed that operations have been undertaken to decompact and level the worst of the damage. This has left an uneven ground surface, and as such public access to this area is to be avoided.
- 7.5. Once the land drains sufficiently the remediation program can recommence, which will see the soil regraded, the larger surface stones removed, and the re-establishment of a meadow grass sward.

- 7.6. Badger Alley is bordered to either side with mature hedgerows, which provide valuable nesting and foraging habitat for local birds.
- 7.7. Given the significant damage to the soils along Badger Alley it is advisable to monitor these hedgerows for signs of stress. Any failures should be removed and the gaps replanted. The larger branches should be cut to half-metre lengths and retained within the hedge as additional habitat.
