OPEN SPACE CONDITION ASSESSMENT

**Little Stanion Farm Management
Company**

Little Stanion, Corby

Ref: 15-3182

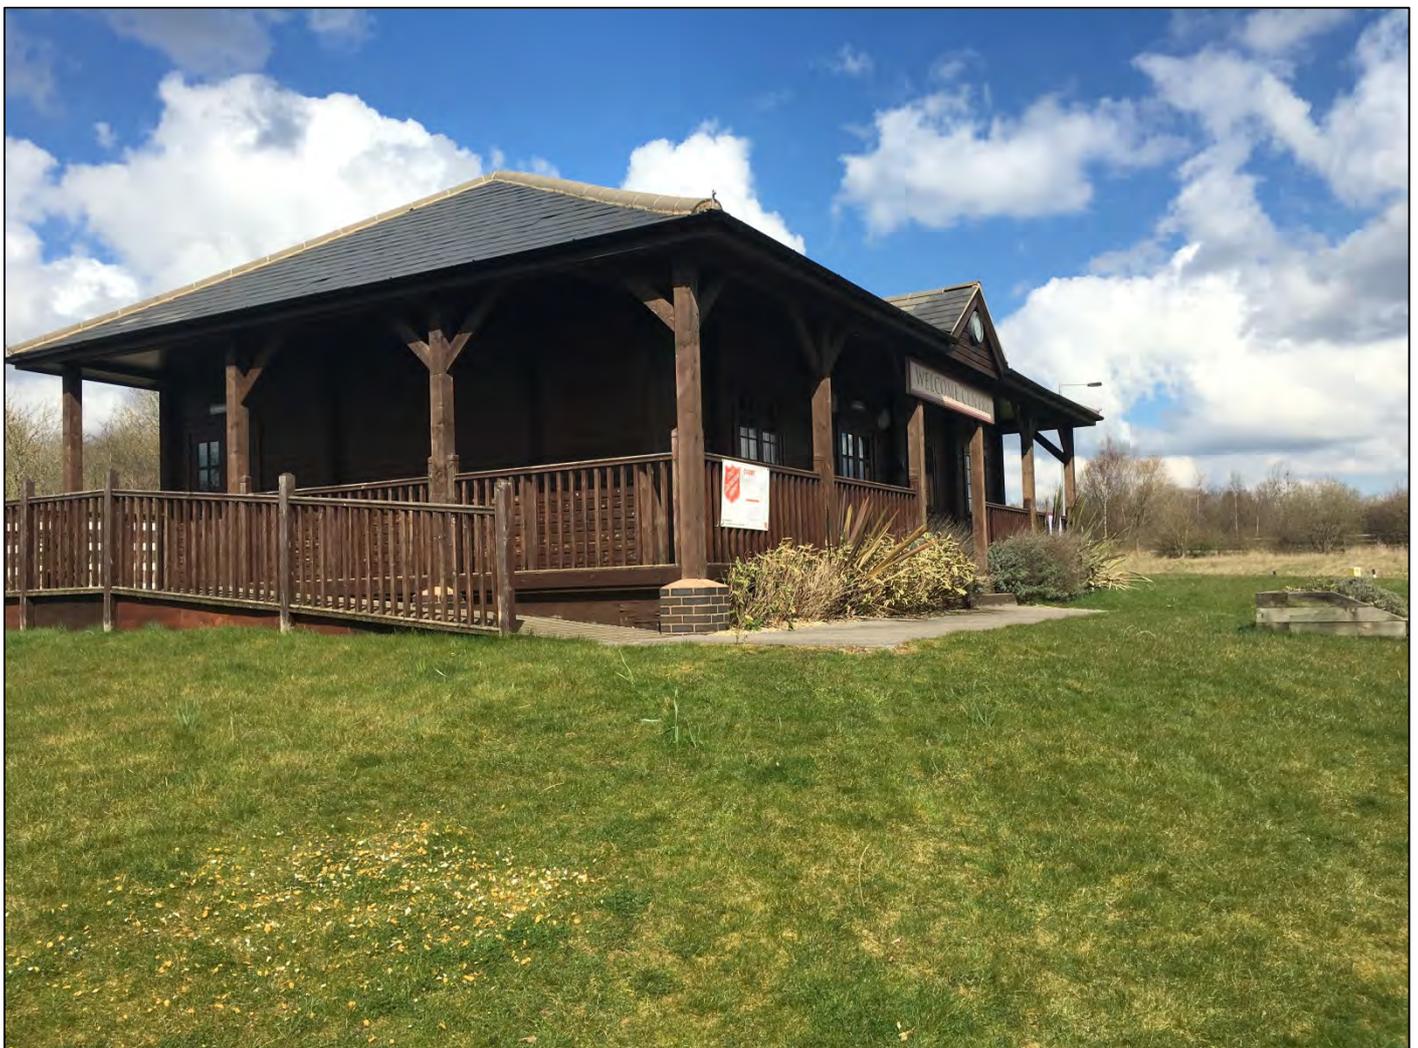
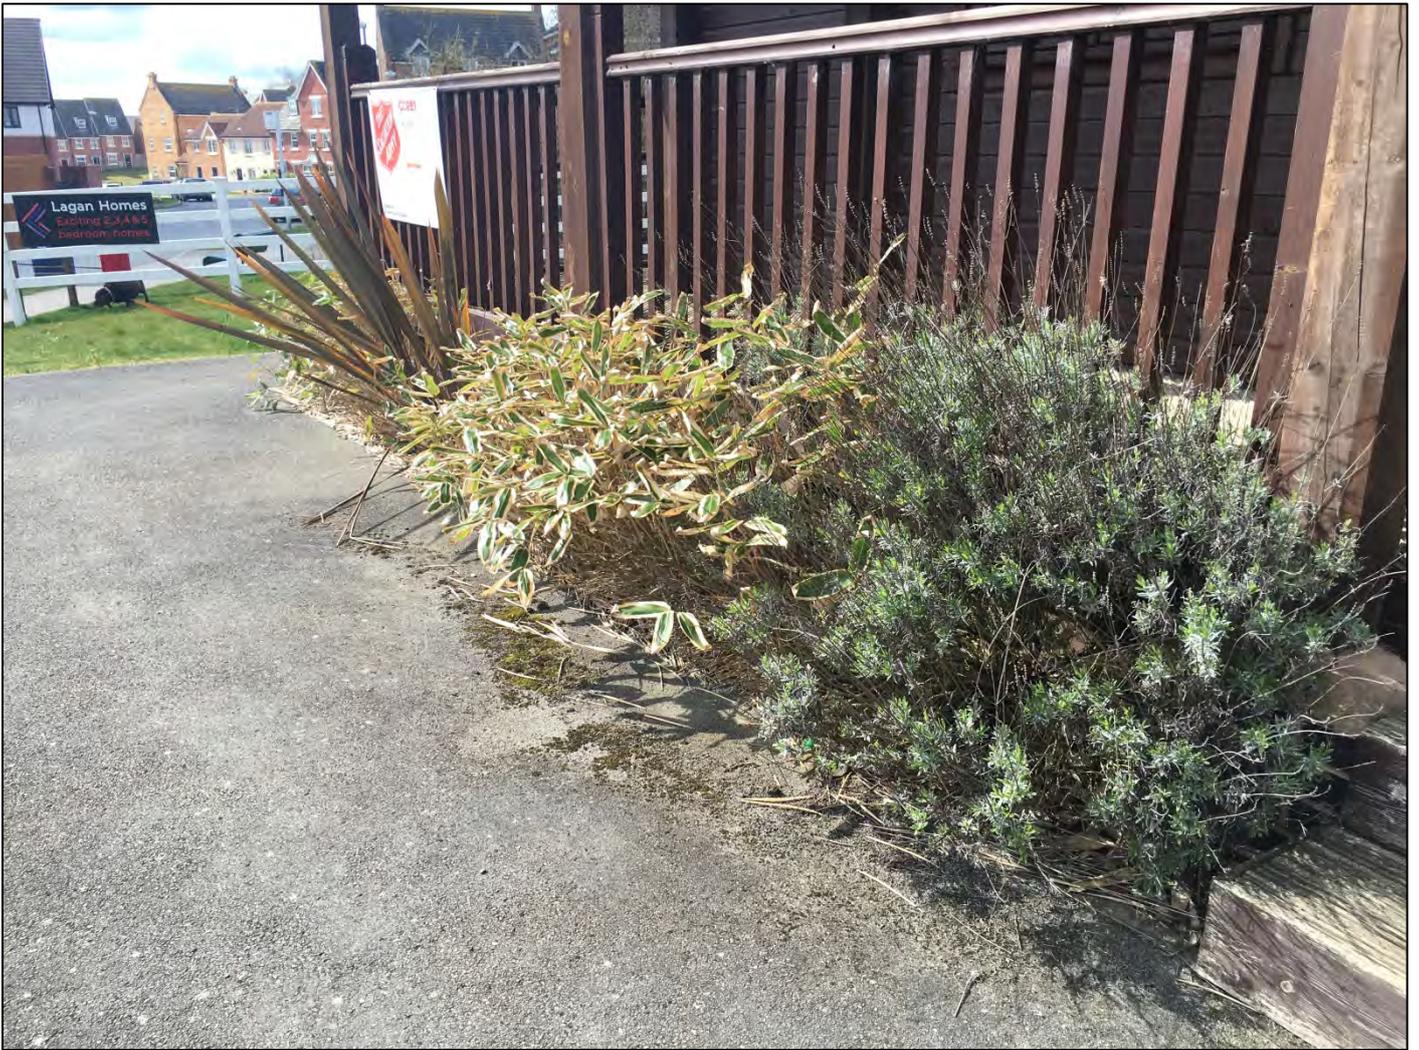
8.3. The grass is in good condition with no broadleaf weeds present. It has yet to be cut this year, likely due to ground conditions.

8.4. Plants are healthy and well-established.
