# Open Space Condition Assessment

Little Stanion Farm Management Company

Little Stanion, Corby, Northamptonshire

Ref: 19-2117  
Version: V1  
Date: 10/02/2020

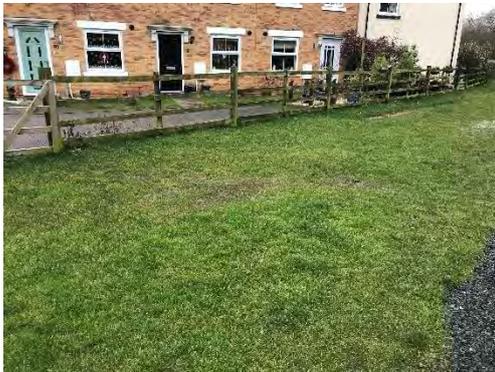
Figure 2

- 2.2. The grass sward is established and is cut to amenity height. The ground was waterlogged and heavily saturated in places, with evidence of water pooling as shown in Figures 1 and 2 below. This is considered to be the result of a period of prolonged wet weather rather than a failure of the site and as such no remedial action is proposed.

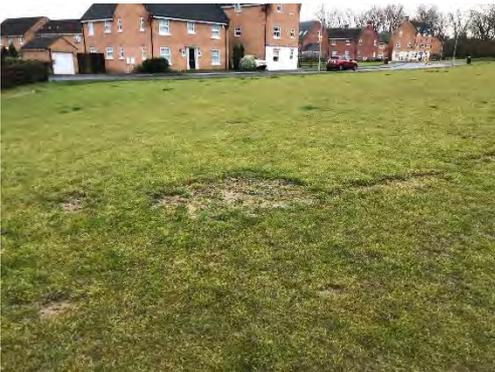
Figure 3

- 2.3. The grass within Top Meadow was patchy in places, with some areas of bare earth evident. This will need reseeding.

- 8.2. Grass to be reseeded in damaged areas.
- 8.3. Relocation of trees (orange marked) away from the property boundary of No. 73.

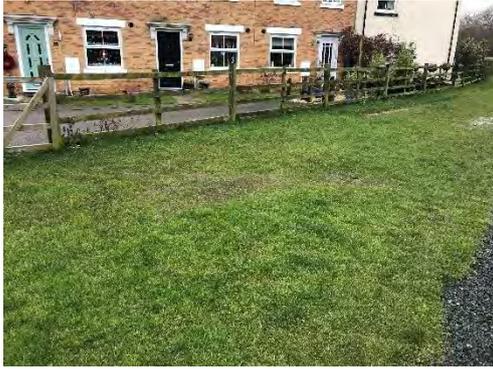
Figure 5

- 2.4. The boundary fence with the adjoining properties was damaged in places, with some rails missing. In addition an access gate from the adjoining properties was noted within this fence. It is unclear whether this access was permitted. Remedial actions will see the missing rails in the fence replaced and the access gate removed should this not be a permitted feature.

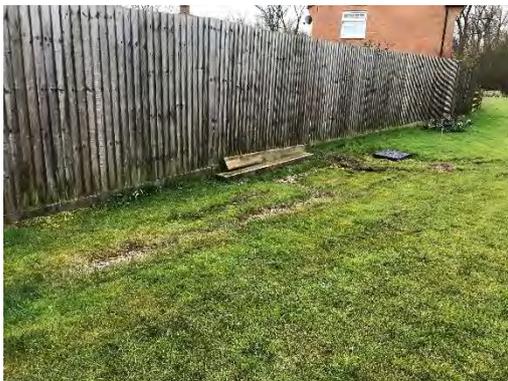
Figure 6

- 2.6. A French Drain appears to have been installed in a localised area adjacent to one of the property boundaries along the southern edge of Top Meadow where water appears to have been draining across Top Meadow and towards the rear garden of this property. Debris associated with this installation remains adjacent to the garden boundary at this point. If this drain is permitted then debris should be removed, and the drain formalised along this boundary.

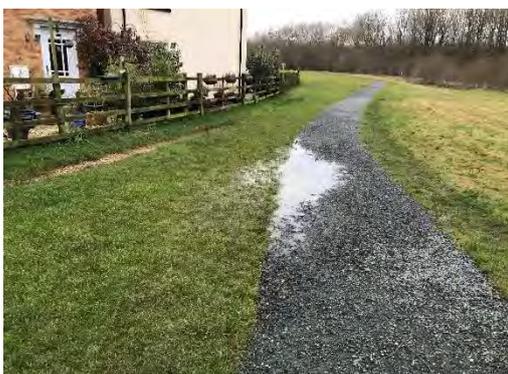
Figure 9

- 2.7. No ruts were evidenced on or adjacent to the pathways within Top Meadow at the time of the survey. Water was, however, covering the pathway in places.

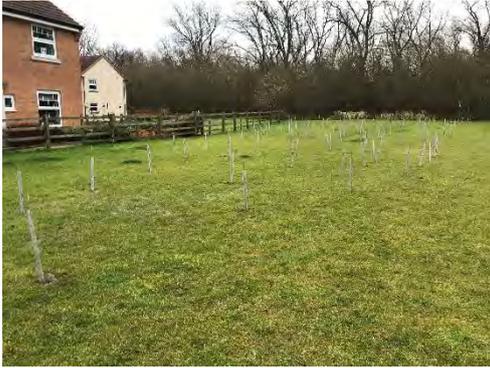
**Figure 11**

- 2.8. The area of tree planting was identified along the western edge of Top Meadow by the link to the Roman Road. It was confirmed that a number of trees adjacent to residential property No. 73 had been queried by the residents as lying too close to their property. As such a number of trees (orange sprayed) were identified to be relocated away from the property. Remedial action will see these trees relocated away from the property.
- 2.9. Some waterlogged areas were evident within this planted area, and any trees that subsequently fail as a result of this are recommended to be replaced.

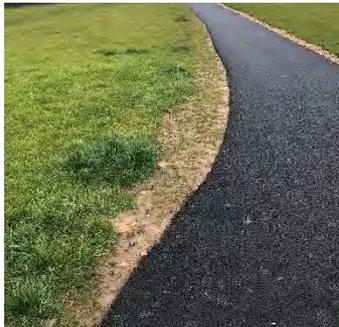
Figure 12

- 3.3. The grass sward is well established and has been cut to amenity height. Areas of poor grass cover were evidenced throughout this area, primarily adjacent to pathways. Application of grass seed will therefore be required.

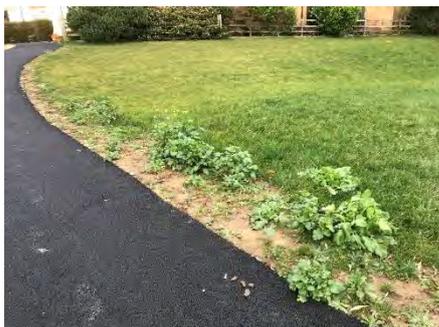
Figure 16

- 3.4. Some broadleaved species are noted to have grown adjacent to pathways where grass has failed. It is recommended that these be cleared and grass reinstated.

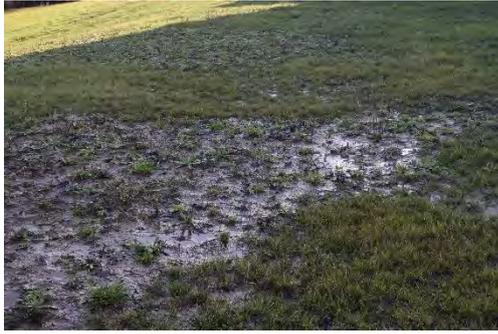
Figure 18

- 3.5. The ground within the southern section of Long Meadow was noted to be heavily compacted and waterlogged. Grass in this area is incredibly patchy (Fig 17&18) with areas adjacent to the lake completely destroyed by construction traffic (Fig 19&20). It is recommended that when construction is complete, the ground is to be levelled and the grass in this area reinstated.

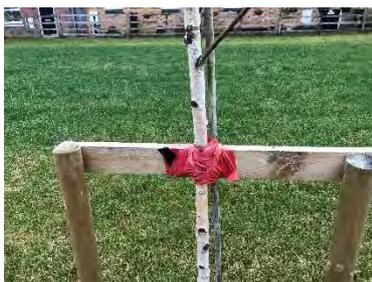
Figure 21

3.6. Throughout Long Meadow the majority of planted trees were in good condition with no obvious defects. There were however, a number of trees towards the lower end of the Meadow whose crowns had been snapped, or who had missing tree ties. A number of trees had also been cable tied to their canes and were now displaying signs of affected growth as a result, with the ties cutting in to the trunks. Cable ties on all trees are therefore to be removed. Damaged trees are to be replaced and damaged tree ties to be replaced.

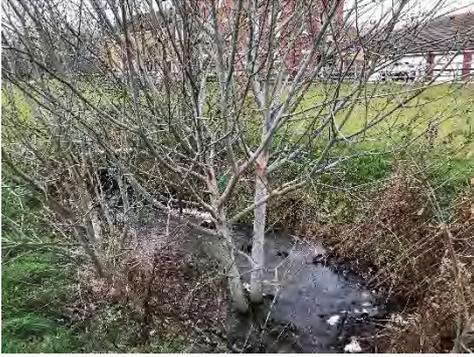
Figure 25

3.7. Within the SUDs basins a number of trees appeared to have been marked. It was unclear as to whether this was for removal, however it is considered that a number of trees within these drainage channels were either damaged or growing too large for the area and so removal is recommended.

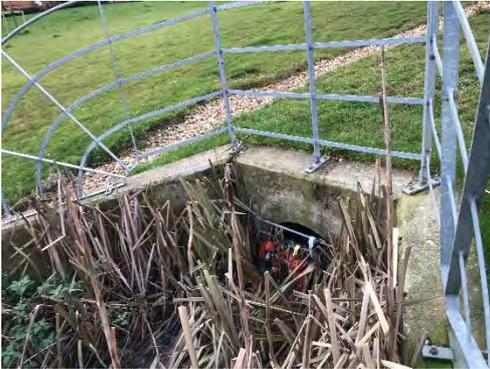
Figure 26

- 3.8. Rubbish and debris was found within the SUDs basins with evidence of plastic waste and, within the lower basin, a child's car seat. A large proportion of this litter was caught in one of the grates along the SUDs channel with the potential to restrict flow should this level of debris increase. This debris should therefore be removed and grates cleared.

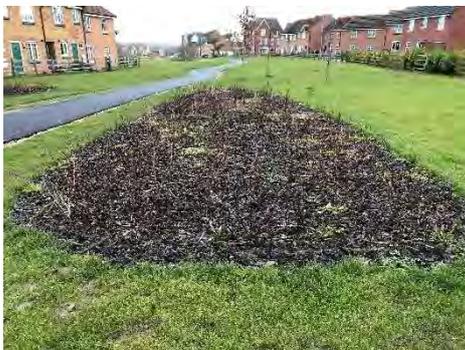
Figure 29

- 3.9. Within the planted beds there was evidence of weed growth and so this will need to be monitored, with weeds removed as required. As the site observation was undertaken in winter, plant health was not able to be identified and as such further summer assessment will be required. Mulch within these beds was also running low in places with some bare earth evidenced in patches. Mulch will therefore need to be topped up in these locations.

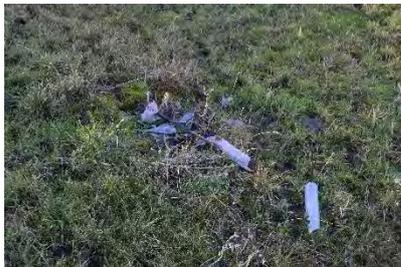
Figure 32

- 4.4. The woodland appears well established, however a number of damaged trees were evidenced along the eastern edge of this bund, with snapped or broken guards and missing crowns, potentially as a result of deer damage. These will therefore need to be replaced.

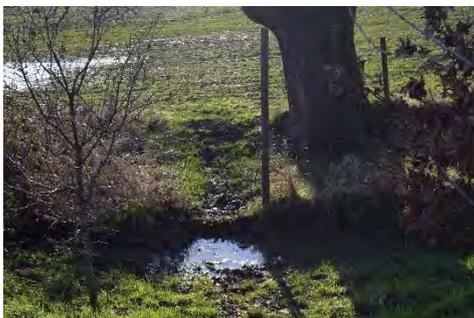
Figure 34

- 4.5. Some fence damage was observed along the northern and eastern fence line. Along the western boundary a number of accesses were also evidenced. It was not clear whether these are permitted however. Remedial access will therefore require repairs to the fence and blocking of unpermitted accesses to the wider landscape to the west.

- 8.9. Repairs to fence recommended to discourage deer and unpermitted access.
- 8.10. French drain within northern section to be repaired and ground levelled before reseeding.

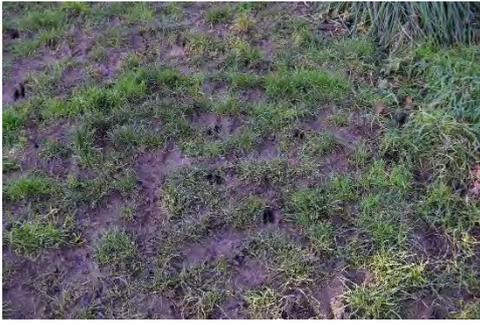
Figure 35

- 4.6. The pathways in this area are relatively well maintained however within the northern section the ground is heavily saturated and well-trodden with grass mostly destroyed. Deer slots are also evident within this areas. Grass to be reseeded.

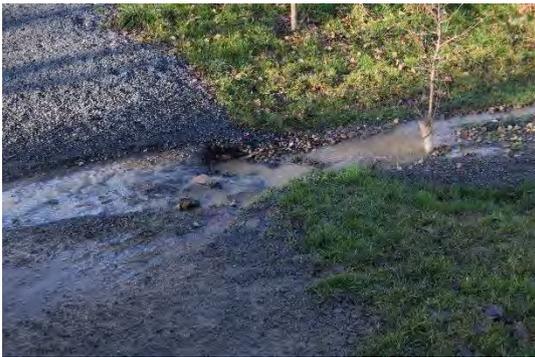
Figure 38

- 4.7. Within the top section of the Southern Wooded Bund the French drain that crosses the path appears to have been significantly deteriorated with water spilling across the path towards the swale along the eastern edge of this boundary. The land at this point appears to be significantly rutted and the grass too appears to have been destroyed. This land will need to be levelled and grass reinstated.

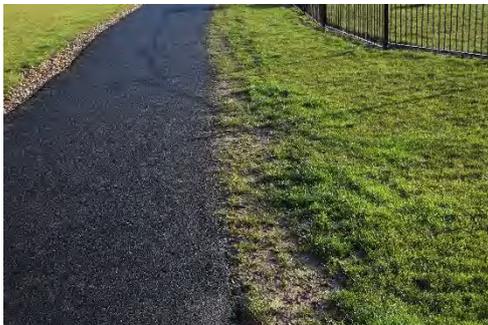
Figure 39

- 5.3. The grass in this area is generally well established, although some of the grass adjacent to the pathways is patchy and has been somewhat deteriorated with some additional areas of deteriorated grassland evident close to the roadway that bisects this section. Grass is to be reseeded in these locations.

- 8.11. Some reseeding required on areas of damaged grassland.
- 8.12. Replacement of damaged tree ties and removal of cable ties on trees to ensure growth is not impeded.
- 8.13. Litter to be removed from swales and grates to ensure that flow of water is not restricted.

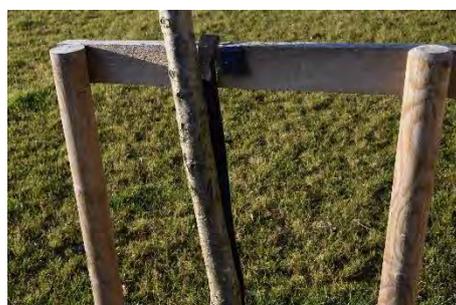
Figure 41

- 5.5. The majority of trees within this section are healthy and well established however, as within Long Meadow, a number of tree ties have been damaged. A number of trees had also been cable tied to their canes and were now displaying signs of affected growth as a result, with the ties cutting in to the trunks. Cable ties on all trees are therefore to be removed and damaged tree ties replaced.

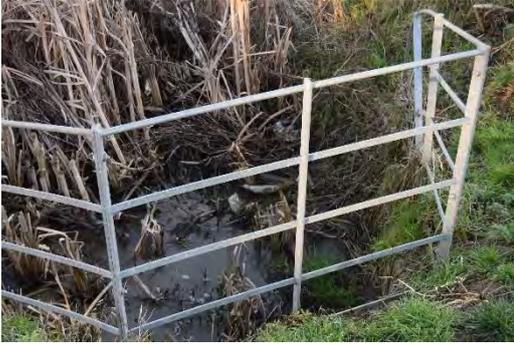
**Figure 44**

- 5.6. Some evidence of littering was found within the SUDs basin with litter caught within the grills. Litter to be removed.

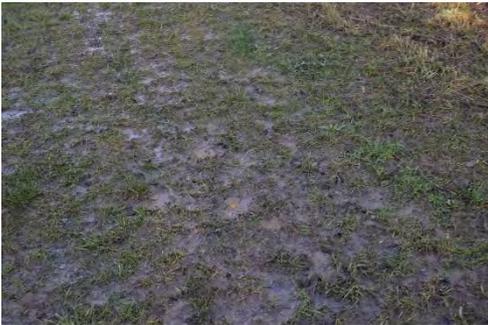
Figure 46

- 6.3. Grass was, for the most part, in good condition however heavily saturated and patchy in places due to pedestrian traffic and heavy rainfall prior to the survey. No remedial action required.

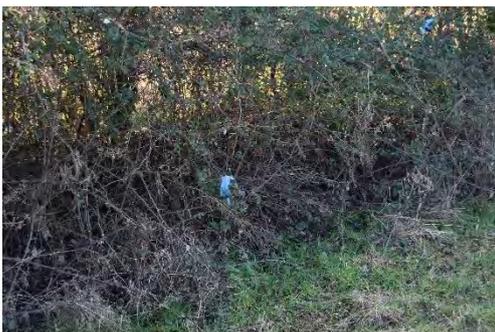
Figure 48

- 6.5. The area was for the most part litter free however several bags of dog foul were evidenced to be hanging from the hedgerow. These are to be removed.

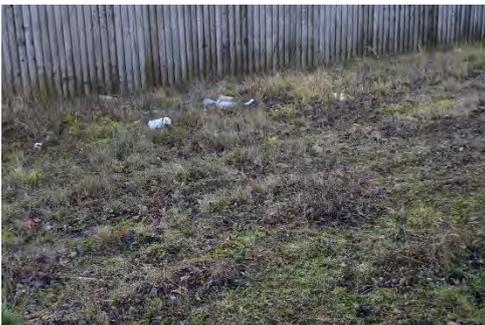
Figure 50

#### *Woodland*

- 8.14. Ongoing management and removal of litter from small section at the rear of properties along Roman Way.

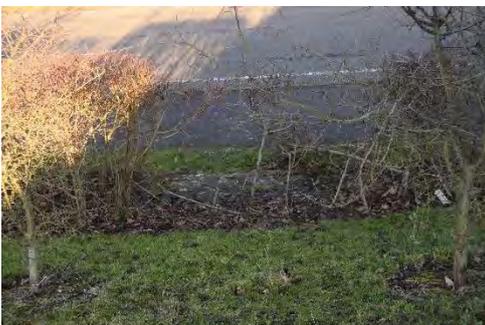
Figure 51

- 7.5. Hedgerows appeared well established and managed however some gaps in the hedgerow were evident and may require replacement/management going forward.
