OPEN SPACE CONDITION ASSESSMENT

Little Stanion Farm Management Company

Little Stanion, Corby, Northamptonshire

Ref: 18-2296
Version: 1
Date: 31/01/2019

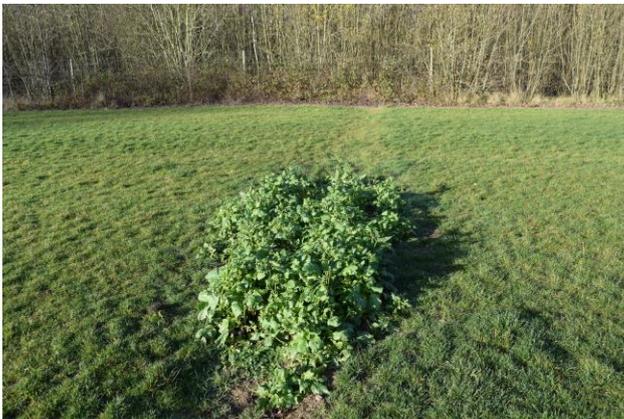
Fig.1

- 2.2. The grass sward is fully established and recently cut to amenity height. Ground was wet in places, although this has not caused establishment issues. No remediation is necessary.
- 2.3. Some broadleaved species developing along the edge of the footpath, and in some patches to the north-west near the entrance to the public footpath. This is to be sprayed off. (Fig.1)

- 9.2. Application of herbicide and clearance of French drain where vegetation has overgrown.
- 9.3. Herbicide treatment of any broad-leaved species growing along the edge of footpath. Care is to be taken to minimise herbicide contact with the adjacent grass sward, e.g. by use of a weed wipe or similar.

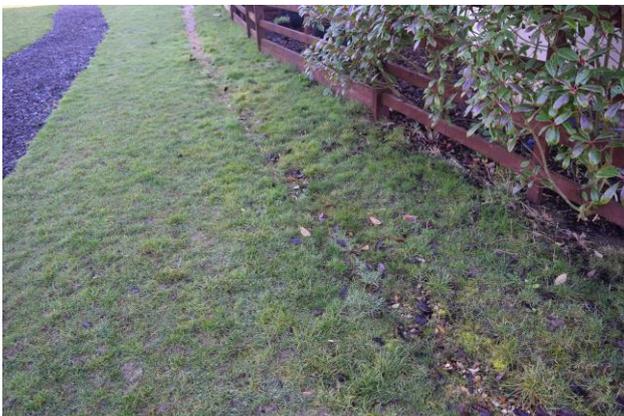
Fig.2

- 2.5. French drain notably overgrown with vegetation in a few patches along the residential fencing in the north-east. This is to be cleared out with a line of herbicide applied. (Fig.2)

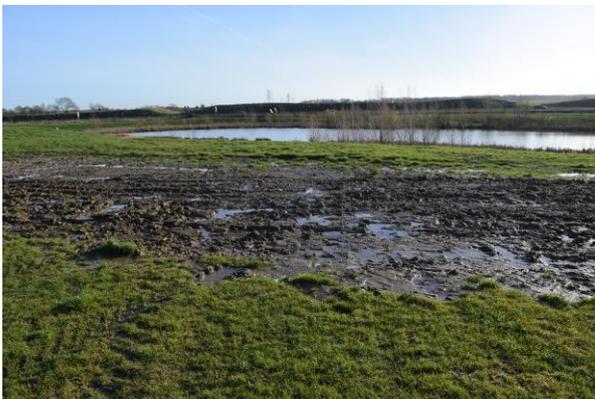
Fig.3

- 3.4. At the south end of Long Meadow meeting Roman Road, two new French drains have been installed. Application of grass seed is necessary.
- 3.5. The bottom section of Long Meadow closest to the Lake was observed to be highly compacted and water logged. A large section of the grass has also been completely destroyed by construction traffic. It is recommended that once the construction process is complete, the ground is to be levelled and grass reinstated. (Fig.3)

- 9.4. Poisoning and removal of willow species from swales and basins to avoid encroachment within the mid-section of Long Meadow.
- 9.5. Herbicide treatment of patches of broad-leaved species developing within the mid-section of Long Meadow and reinstatement of grass sward.
- 9.6. Ground levelling within the bottom section of Long Meadow and reinstatement of grass sward.

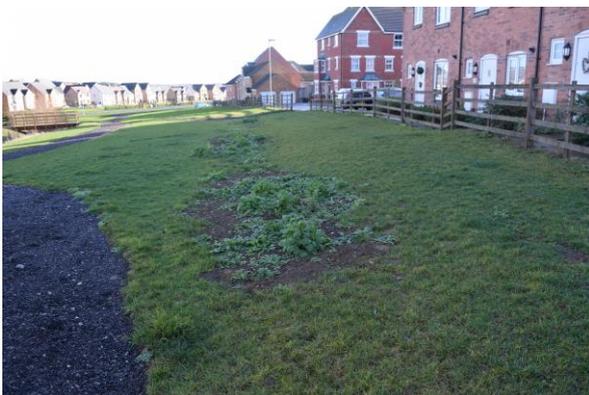
Fig.4

- 3.6. Some broad-leaved species noted to have developed in 3 patches within the middle section of Long Meadow. It is recommended that these be cleared and grass reinstated. (Fig.4)

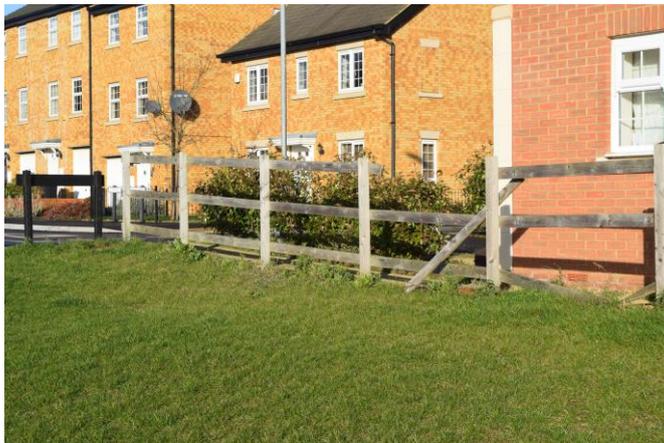
Fig.5

- 4.6. Fencing was found in good condition overall, with the exception of 2 broken rails besides the corner property where Mendip Way meets Short Meadow. (Fig.5)

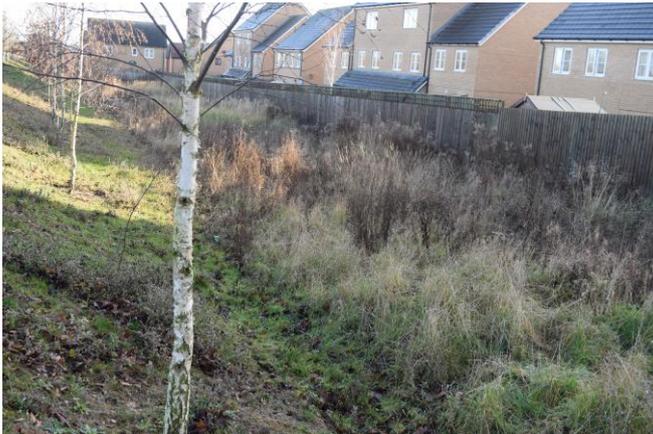
Fig.6

- 5.3. The trees are establishing well, with no requirement for remedial action.
- 5.4. Grasses and broadleaved weeds have started developing around the bases of trees, and therefore herbicide application may be required in March and July as per standard practice.
- 5.5. Bottom edge of the bund, along the rear gardens of properties along Roman Road, is overgrown and unmanaged. It is recommended that this area be strimmed off and then mowed as part of the site wide regime. Some fly tipping over garden fences was also observed in this area, and regular maintenance will assist in deterring this activity. (Fig.6)

- 9.7. Herbicide treatment of broad-leaved species around tree stations and clearance of overgrown vegetation at the small section at the rear of properties along Roman Way.

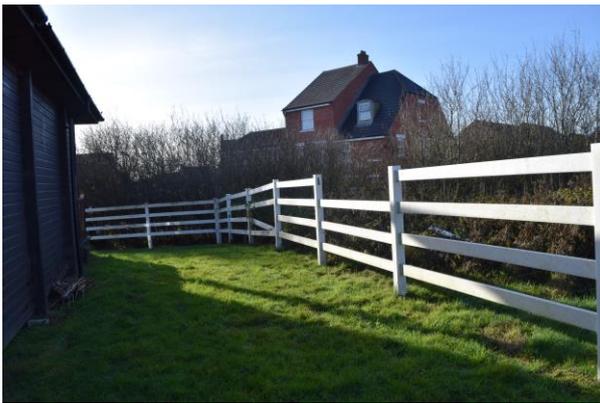
Fig. 7

- 8.4. Overall in good condition, two rails need replacing behind Welcome Centre. (Fig.7)
