Open Space Condition Assessment

Little Stanion Farm Management Company

Little Stanion, Corby, Northamptonshire

Ref: 21/1422
Version: V2
Date: 17/12/2021

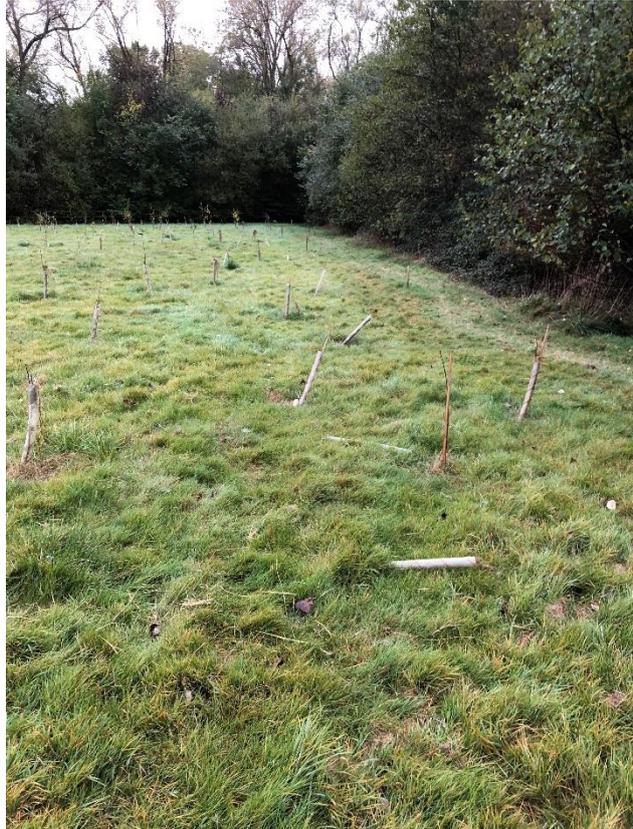
- 2.6. A number of supporting canes and spiral guards were either broken or missing. Some stock was found to have failed. Spirals were also seen that were choked with weeds and grass.
- 2.7. These trees were not part of the original landscape masterplan, rather were planted by a community group. Therefore, their maintenance and upkeep is not specifically the responsibility of the management company.
- 2.8. It is clear that if these trees do not receive the seasonal maintenance operations required, they are likely to fail in great numbers. Therefore, it is recommended that discussions are held to establish this management regime to ensure the longevity of this community asset.

- 8.2. Grass should be reseeded in damaged areas.
- 8.3. Young community woodland to be maintained, including removal of grass from shelters, replacement of shelters and canes where they are missing or damaged, and replacement of failed stock.

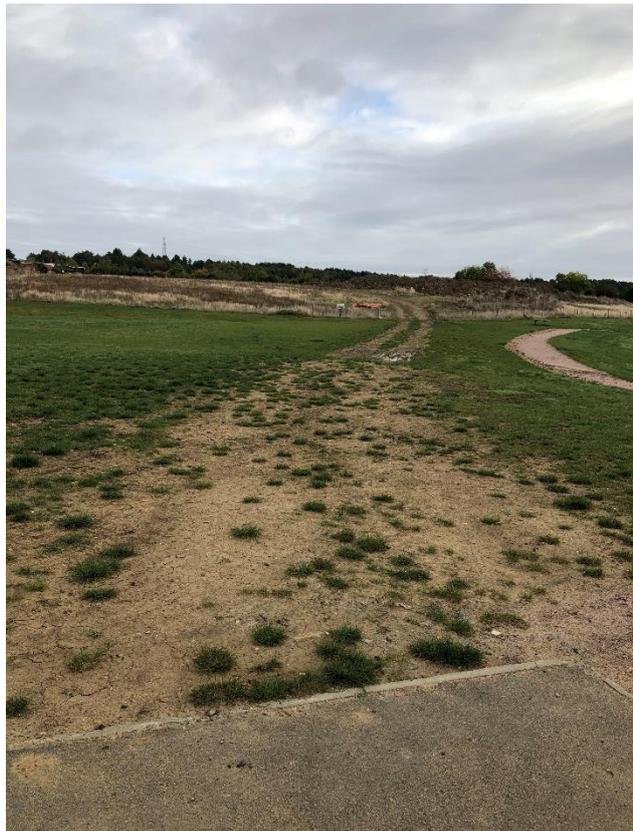
- 3.4. The grass had not been mown immediately prior to the inspection; however, it was clear that it receives regular cuts and has not been neglected. In several places, the grass adjacent to the path edges had died back, likely through a combination of underground kerb haunching and human erosion. Repairs to these patches would improve the overall experience of Long Meadow, although it is likely to be an ongoing recurrence.

- 3.5. To the southeast of Long Meadow there was evidence that vehicles had been tracking across the grass between Brecon Close and the undeveloped land to the south of the Primary School. This has degraded the area and will require remediating once works are complete. It is noted that this area is still incomplete, with a MUGA and a number of trees to be planted, as well as some regrading associated with the forthcoming development to the north. It is important that the compacted ground that will remain either grass or soft landscaping is de-compacted and properly established as part of the landscape construction works.

- 8.4. Cut vegetation within swales.
- 8.5. Remove weeds from ornamental beds and top up bark mulch.
- 8.6. De-compact and reseed areas of vehicle tracking.

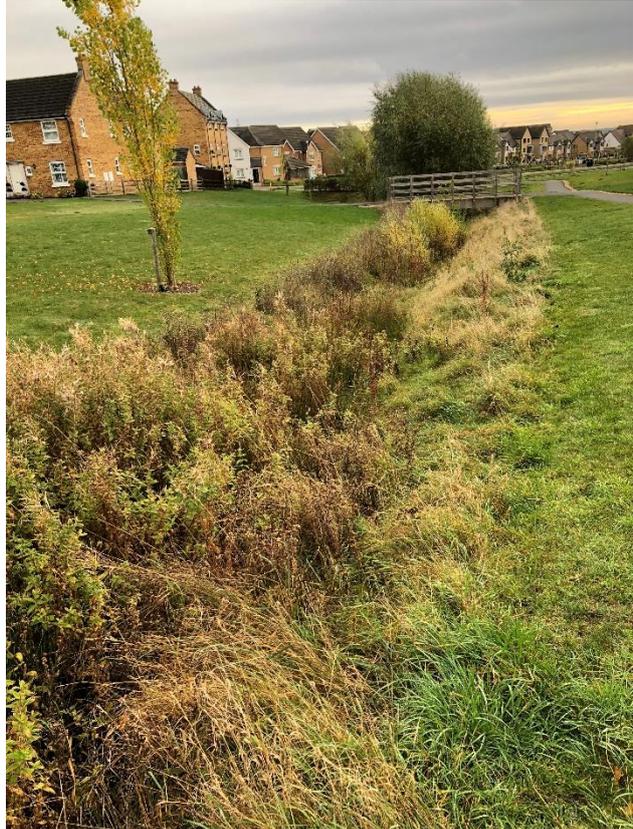
- 3.7. The SUDs and ephemeral basins were well established with marginal plants, and it would be recommended that these are strimmed this winter to keep the drainage system functioning well.
- 3.8. A minor amount of litter was present within the swales; however, it was not unacceptable level, and it did not appear to have been present for a long period.

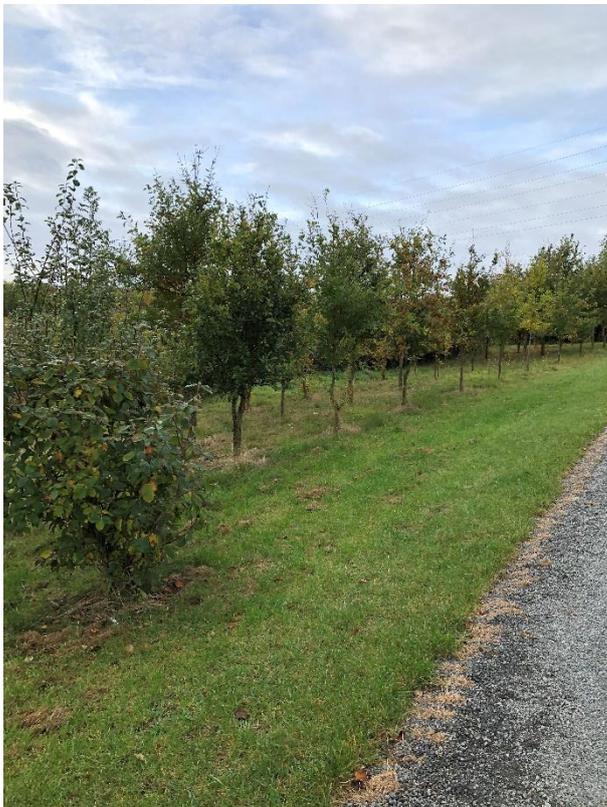
- 4.4. The woodland within this area appears to be well established, however, when on Site it was identified that a number of trees within this section were displaying signs of Ash Dieback, with lesions present on a number of trees as well as the dying back of some crowns.
- 4.5. The woodland is establishing well, although there is evidence that it has suffered from deer damage and ash dieback – neither of which are uncommon locally. Some restocking may be required in the long term; however it is likely that the loss of a small amount of trees will allow the remaining to establish better, with increased space and light levels being to their benefit.

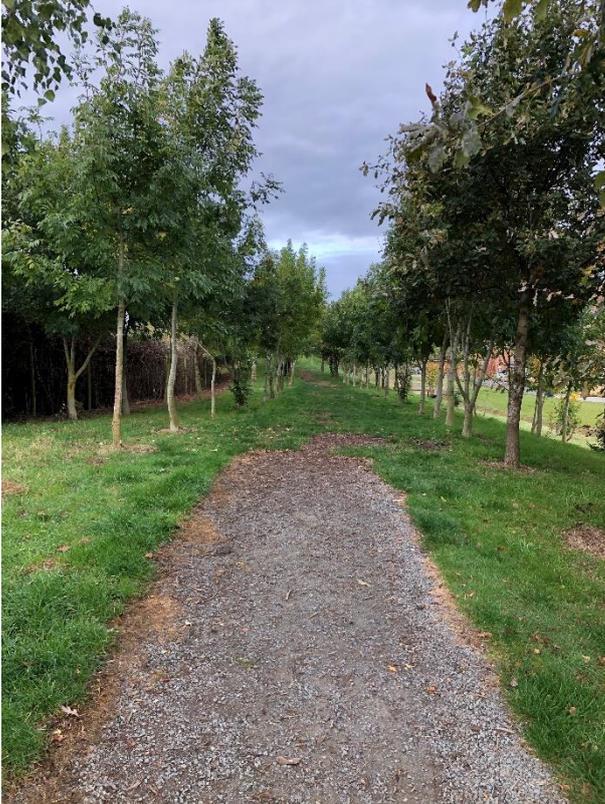
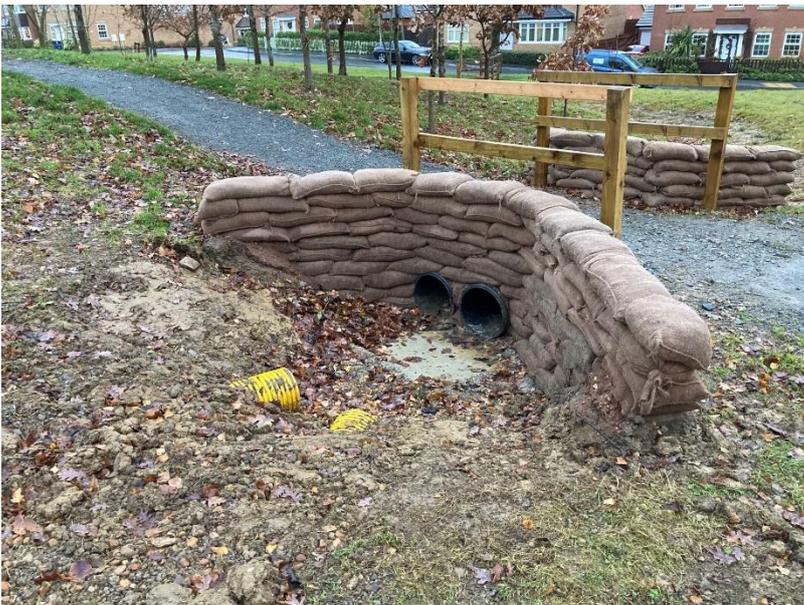
- 4.6. The pathways in this area are informal, and morph from aggregate to a simple mown route. Some work has been undertaken to try to drain the pathways, and ditches and pipes have been installed to divert and contain surface water.

- 8.7. French drain within northern section to be repaired and ground levelled before reseeding.

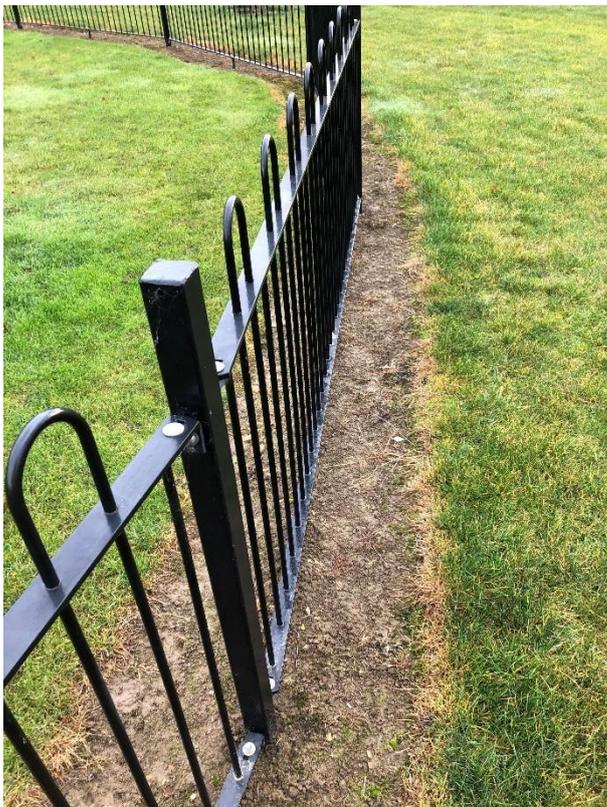
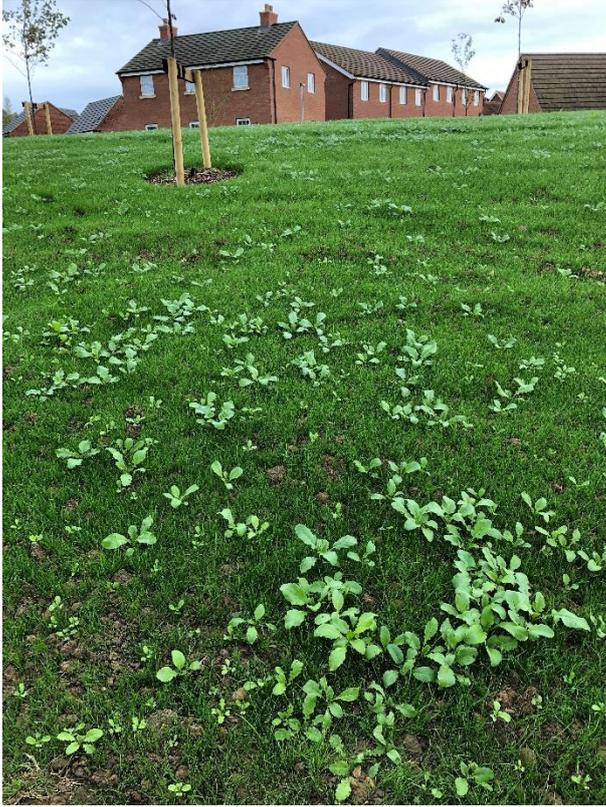
- 5.3. The grass in this area is well established in the north, although some of the grass adjacent to the pathways is patchy and worn. The bow-top fence that encloses the play area has been sprayed off with an herbicide, which has left an unsightly brown strip beneath the fence. If this was controlled with a strimmer it would leave a more attractive finish.
- 5.4. The reprofiled area to the south was seeded with meadow seed. This will take a number of seasons to establish properly; during this time it will require maintenance to remove any unwanted broadleaf weeds (such as nettle, thistle, and ox-tongue) prior to seeding, and two-three cuts per annum to encourage root growth.

- 8.8. Continual management of the meadow areas to ensure establishment.
- 8.9. Change management of the grass beneath the bow top fence to strim.

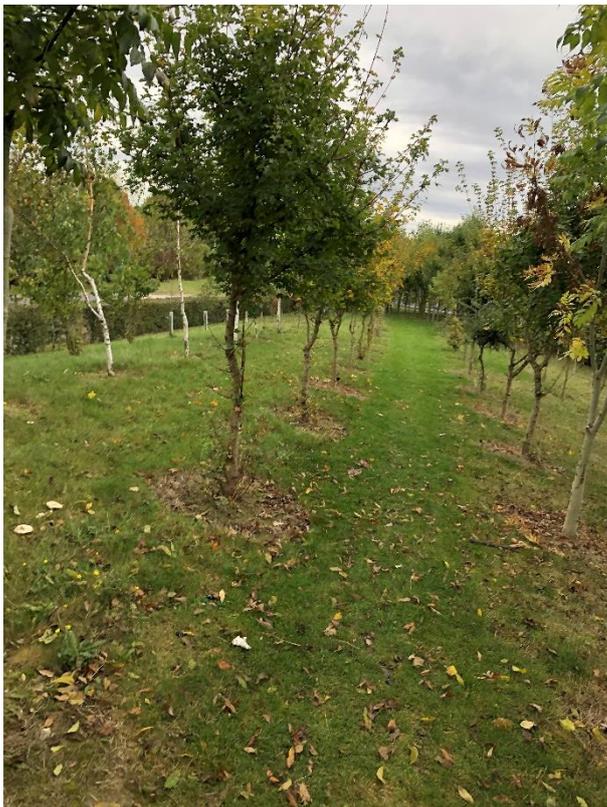
- 7.3. The woodland and trees along this bund have established well. Guards and stakes have been removed and the trees are for the most part looking healthy; however, as noted within the southern wooded bund Ash Dieback was evident. In addition, a number of other trees appear to show some pest damage but are not anticipated to require replacement. No remedial action required.

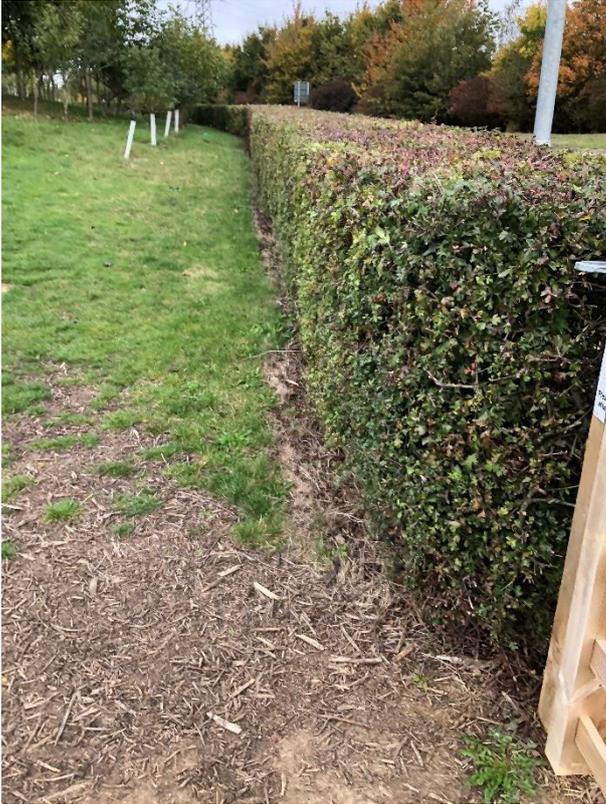
- 7.4. The hedge that fronts this area is well maintained and in good condition.

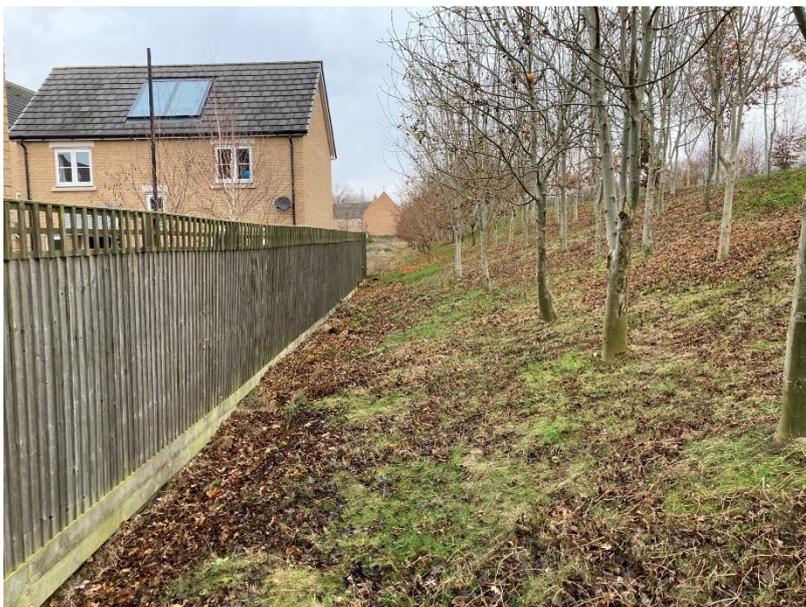
- 7.5. The rear slope of the bund abuts a number of dwellings, and the tree planting is offset so as not to overcrowd these properties as they establish. There is evidence that garden waste has been dumped over the rear boundaries from properties abutting this area, and the management company need to make regular visits to rectify this. As seen in the image below, the area has been recently cleared.

- 8.10. Ongoing management and removal of litter from boundary with properties.
