Landscape Condition Assessment

Little Stanion Farm Management Company

Little Stanion

Date: 23/10/2023

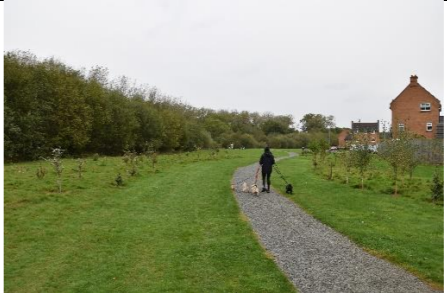
Bridges	All bridges in good condition.		
	Amenity grass	All amenity grass areas are well managed and maintained. In recent years more areas are now being developed as wildflower meadows and not regularly mown, particularly swale margins. This is strongly encouraged and should greatly improve the biodiversity within the site.		
	Play Areas	Overall, well maintained with evidence of repairs to surfaces. Free of litter. Equipment looks in good condition but not inspected beyond visual inspection. Fencing well-maintained and evidence of weed management by spraying		
Top Meadow	Meadow	In recent years some areas have been converted from amenity grassland to wildflower meadow and some tree planting carried out.	Recommend some infill tree planting into recently planted areas to replace losses and fill gaps. Recommend this area be developed as scrub so suitable UK native species should be selected. Whips or feathers should be used.

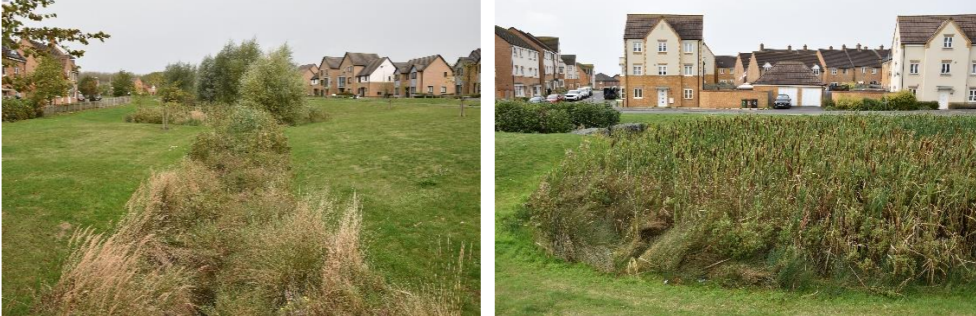
Long Meadow	Swale / SUDS	Established with wildflower and aquatic marginal species which are cut annually at an appropriate time of year. Incursion of bullrush could impede the function of the swale and suds basins in time. Some self-set willow trees have become well-established and others are establishing. There is evidence that the channel entry and exit points are regularly cleared of plant growth, silt, and debris on a rotational basis.	Condition of trees should be regularly inspected as part of an ongoing tree management plan. Recommend coppicing of established willows on rotation. Smaller willow trees should be cut or removed to prevent domination. Bullrush will require periodic digging out to prevent over-domination. Current regime of channel clearing to continue.

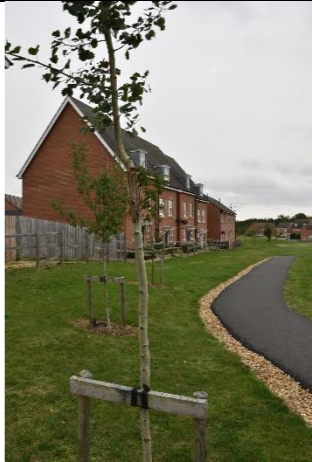
Location	Element	Condition / Observations	Remedial Actions / Recommendations	Illustrative Photographs
	Trees	Generally, most feature trees are establishing well and looking healthy, however some show evidence of damage (vandalism or wind) and some look like they are struggling.	Monitor ongoing growth and consider replacement where no longer viable.	
Short Meadow	Trees	Generally, most feature trees are establishing well and looking healthy, however some show evidence of damage (vandalism or wind) and some look like they are struggling.	Monitor ongoing growth and consider replacement where no longer viable.

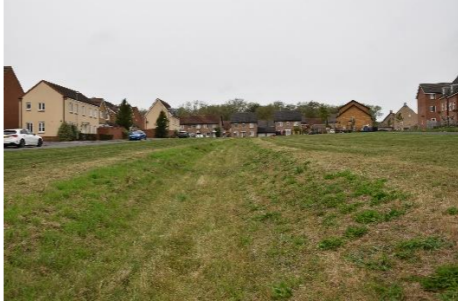
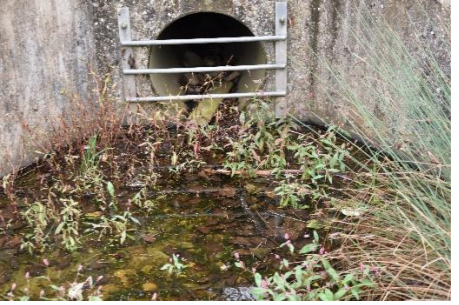
Swale	The swale is mainly populated with grass species and is trimmed/mown once a year. It is free from trees and bullrush.	Debris to be cleared from exit channel.

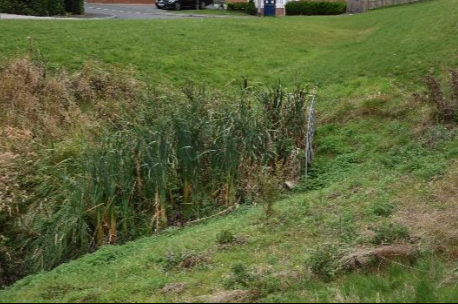
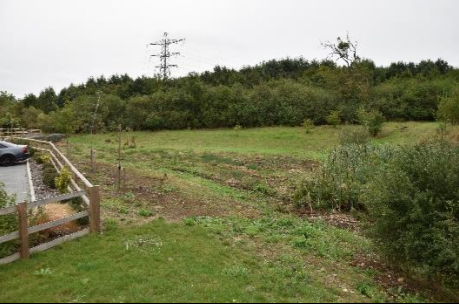
SUDS basin	Evidence that this is in the process of being cleared of bullrushes and de-silted although further work is still required to clear the main inlet and complete landscaping.	Complete clearance work. Re-landscaping of areas around the SUDS will be required following recent building work and clearance of the SUDS.

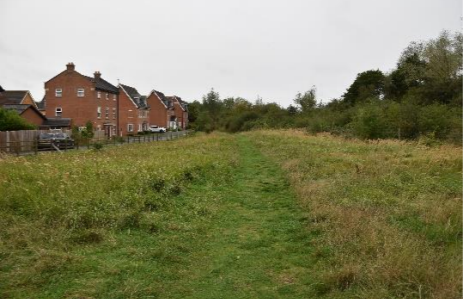
Rear Meadow	Meadow	Well established grassland meadow with mown paths all in good condition.	One willow tree near the path should be inspected as part of a tree survey to assess its safety and advise on management.

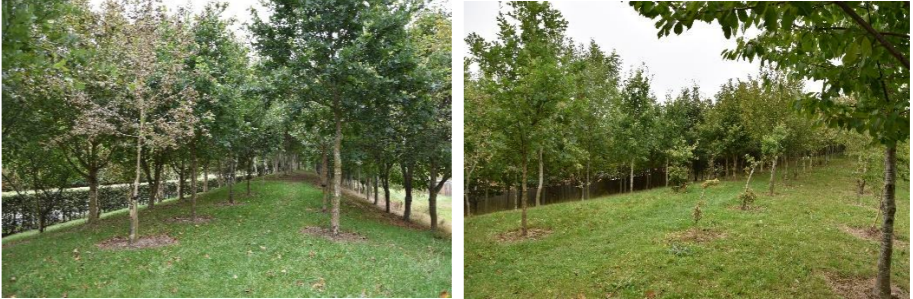
Location	Element	Condition / Observations	Remedial Actions / Recommendations	Illustrative Photographs
Front Wooded Bund	Woodland / hedges	<p>Hedgerow well established and well maintained. Most trees have become well established. Some areas are starting to become overcrowded although there are also some losses creating some thinner areas. Ash dieback is a potential issue and could lead to gaps in the woodland if not correctly managed over the coming years.</p> <p>The eastern end of the bund has been planted more recently and more sparsely with non-native, more ornamental species.</p>	<p>Recommend a woodland survey is undertaken to identify trees to be thinned and advise on management of the ash trees.</p>

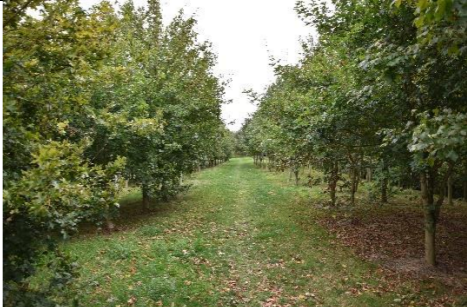
Rear Wooded Bund	Woodland	<p>Well established and at a point where thinning of some trees is required as there is some overcrowding. There are a few losses in places and possible evidence of ash dieback but overall, the woodland has successfully formed a largely dense coverage of the bund.</p>	<p>Recommend a woodland survey is undertaken to identify trees to be thinned and advise on management of the ash trees.</p>

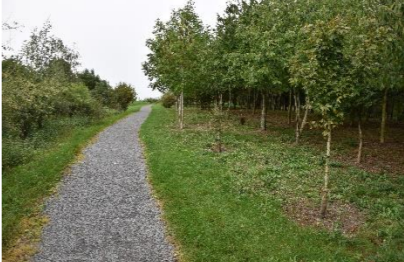
Badger Alley	Whole	<p>Hedgerows are well managed for wildlife and have been allowed to grow out and only trimmed when encroaching too far.</p> <p>Mature ash tree has had dead limbs but those over the path have been removed.</p> <p>Paths are kept mown through the grass.</p>	<p>Recommend an arboricultural survey is undertaken to advise on tree condition and any potential actions.</p>	
Hare Bund	Woodland	<p>Becoming well established, not significantly overcrowded but thinning may be required in places. There are a few losses in places and possible evidence of ash dieback but overall, the woodland is successfully forming a largely dense coverage of the bund.</p>	<p>Recommend a woodland survey is undertaken to identify trees to be thinned and advise on management of the ash trees.</p>

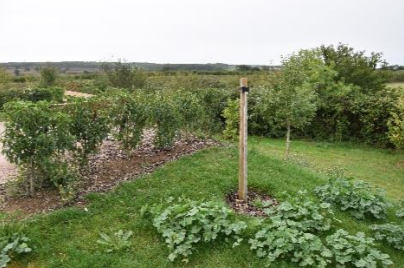
Viewpoint area	<p>Recently planted trees have been damaged by vandalism.</p>	<p>Replace.</p>

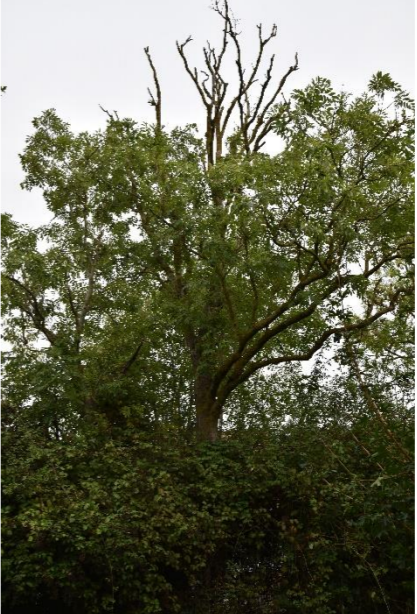
Location	Element	Condition / Observations	Remedial Actions / Recommendations	Illustrative Photographs
	Hedgerow	Pre-existing hedgerow generally in excellent condition however it contains 3 mature ash trees which all contain dead wood.	Recommend an arboricultural survey is undertaken to inspect these trees and provide further recommendations on their management or, if deemed appropriate, removal (subject to any TPO)

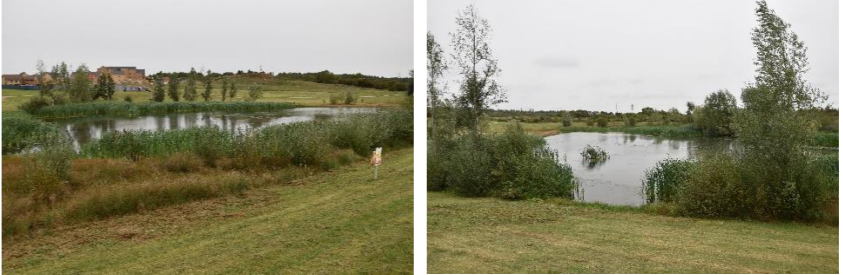
Lake	Lake	The lake looks to be maintained in excellent condition with good proportions of open water. The trees around the lake are being managed successfully so that they are not over encroaching.

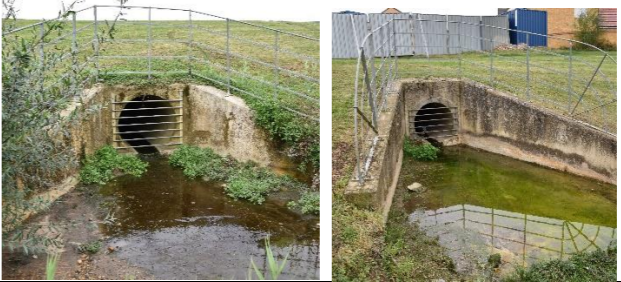
The inlets are being well maintained and are generally clear of plant growth, debris and silt having been recently cleared.

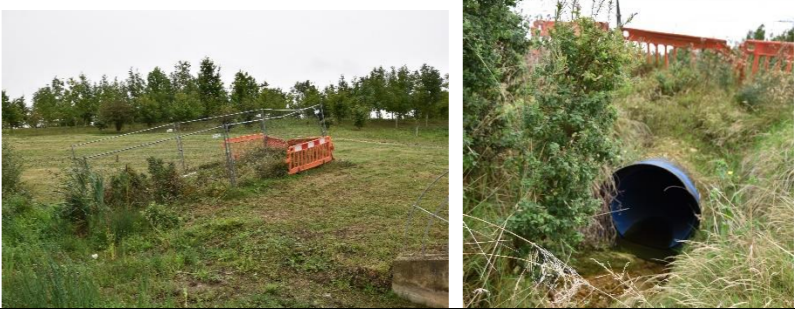
A new inlet has been constructed but not completed and is currently surrounded by temporary mesh fence. The outlet currently has no safety grill.	Work should be completed on this to make safe and landscaping tidied up.

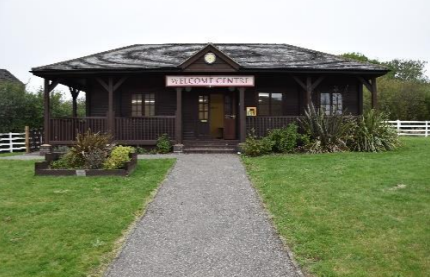
Welcome Centre Green	Ornamental borders	Some planting in front of the visitor centre has been badly damaged by deer. The bed on the left of the centre doorway is too shallow to provide much space for plants and as such they are struggling.	Consideration should be given to some replanting; For shrubs, yew or holly, which deer generally don't like, or dogwood, which will recover quickly from damage. For perennials, recommend bearded iris and lavender which would suit this sunny spot and are low maintenance.
