## **LITTLE STANION**

### **OPEN SPACE CONDITION ASSESSMENT**

**Ref: 26-067**

**Client: Little Stanion Farm Management Company**

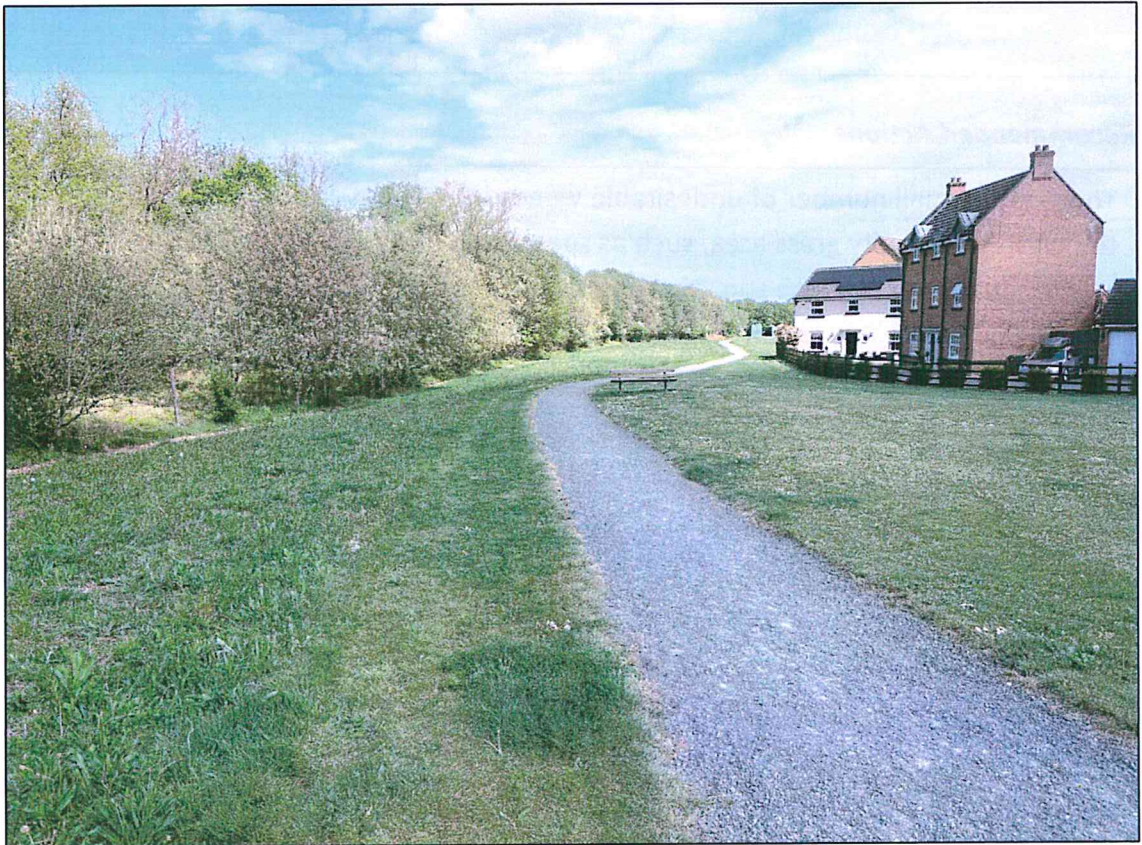
- 2.1 This area largely comprises a combination of close mown amenity grassland and meadow grassland. A compacted aggregate path runs the length of the meadow from west to east, with a connection to Arden Close and Long Meadow to the south. Benches are located next to the path, and outdoor gym equipment is located opposite the Arden Close connection. Loose groups of trees are located at its western end. Encroaching willow trees from the adjacent woodland have been cut back and arisings chipped.

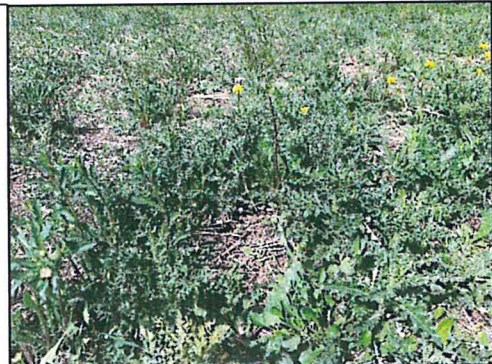
Eastern meadow area is struggling to establish. Cultivate in following autumn and re-seed with a suitable lime tolerant meadow mix such as Germinal WFG5 at 5g/m<sup>2</sup>. Targeted herbicide treatment of thistle if it persists.

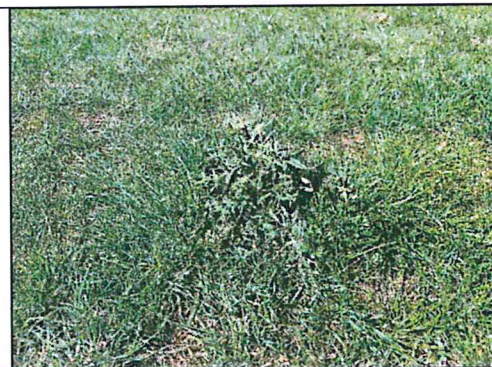
There are a small number of undesirable weeds in the western amenity grass area, such as spear thistle. To be treated with spot spraying with a suitable herbicide to prevent spread.

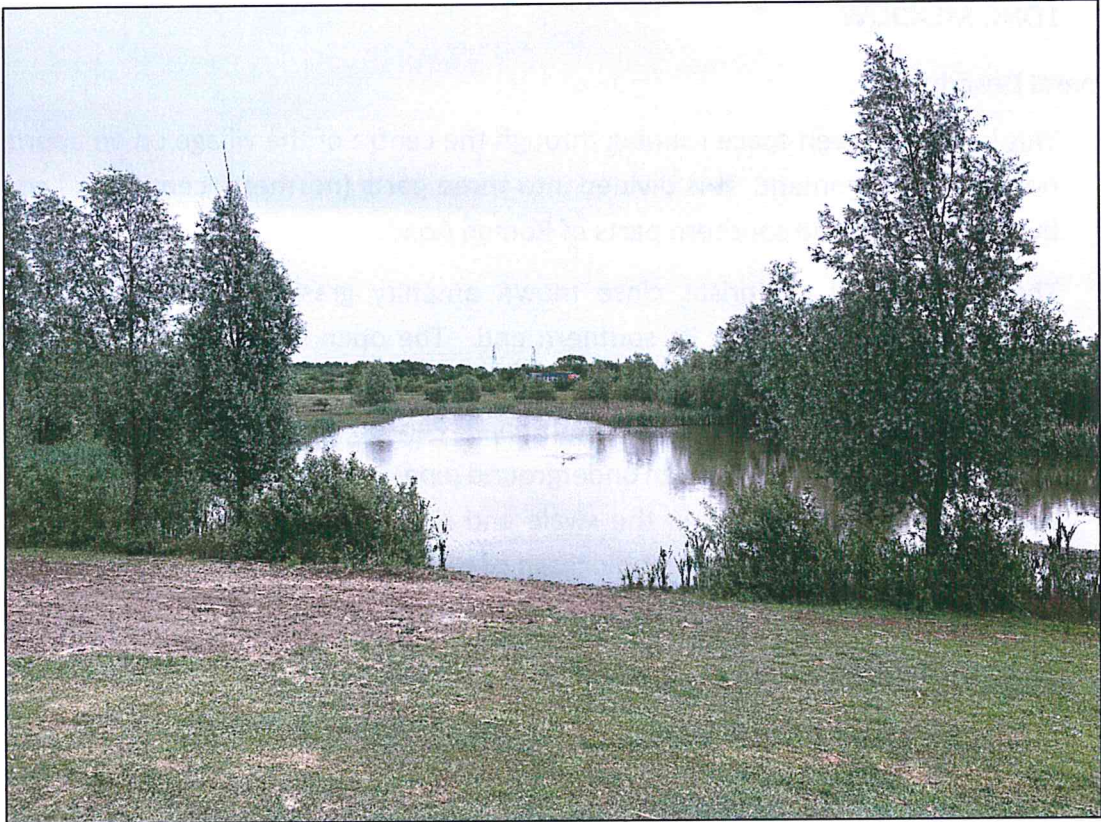
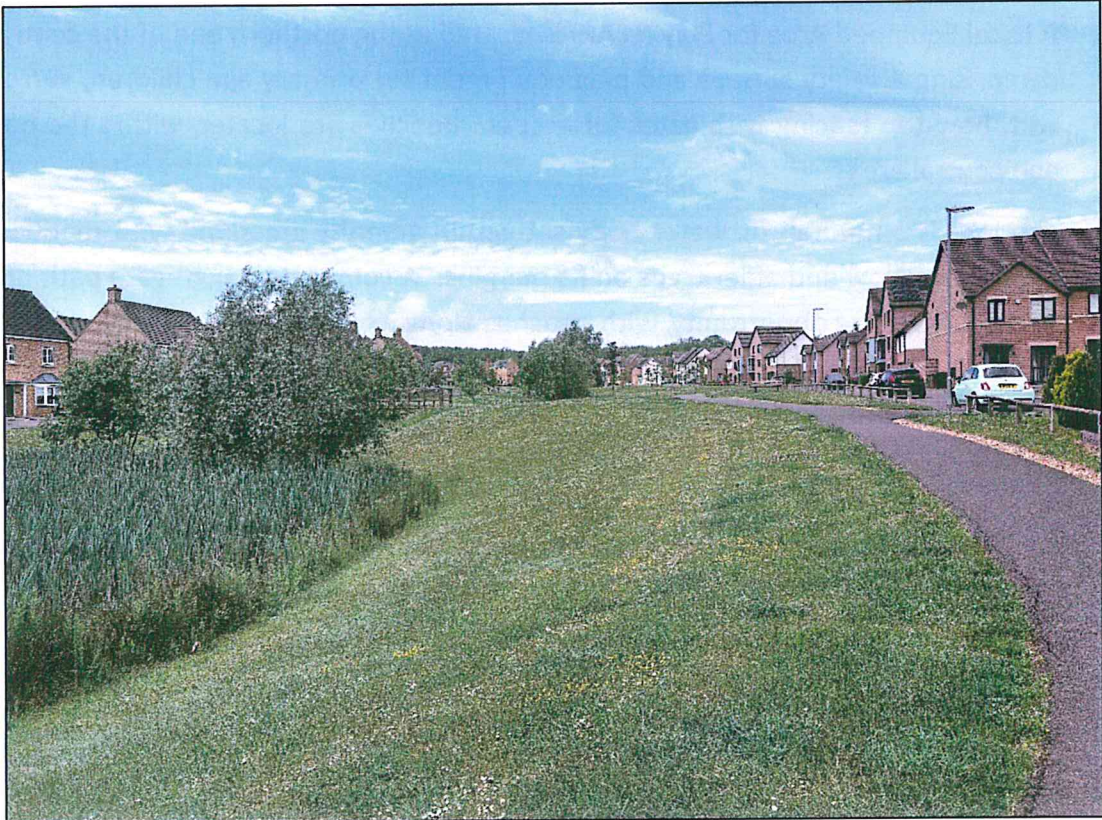
- 3.6 The lake is a naturalistic water body set within amenity grassland with reedbeds and scattered willow and alder trees on its margins. A compacted aggregate path provides a circular walking opportunity, with benches along its length and connections to Brecon Close, the boundary woodland and Badger Alley. Water enters and leaves the lake via fenced concrete headwalls. Bins have been provided for litter and dog faeces.

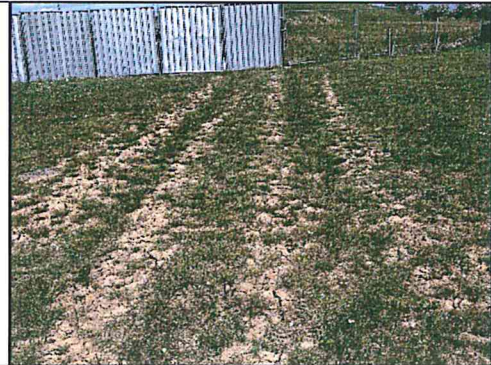
An area of amenity grass has been damaged in the southern area by vehicle tracking, leading to compaction. Area to be cultivated and re-seeded with a suitable amenity grass mix, e.g. Germinal A19 at 35g/m<sup>2</sup>.

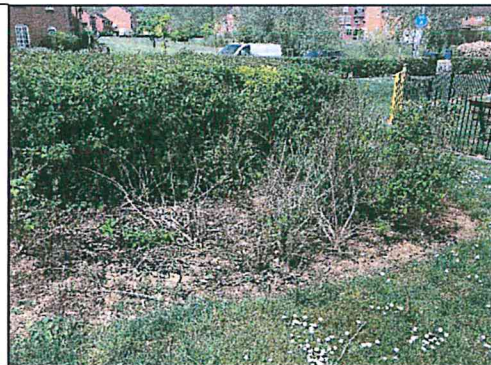
Some species have died in an area of shrubs to the west of the LEAP in the central part. Dead plants to be removed, the areas weeded and re-planted with suitable native woody shrub species such as spindleberry (*Euonymus europaeus*) or guelder rose (*Viburnum opulus*).

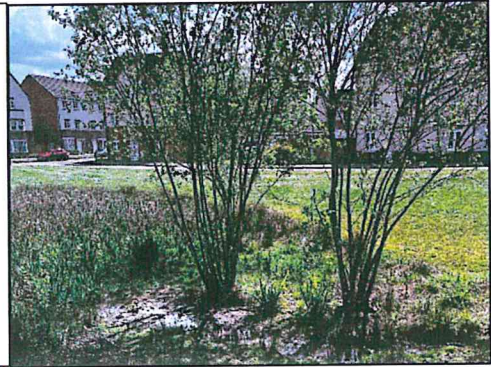
Coppicing of goat willow trees within the swale system to continue, with phased cutting to ground level to ensure a balance between the function of the system and the provision of shade and screening. It is also recommended that a third of the willow trees surrounding the lake be coppiced each year on rotation.

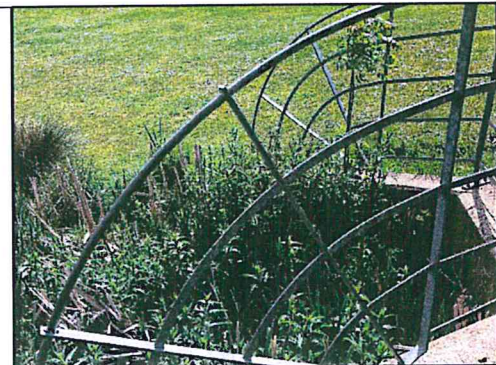
An ash sapling, rosebay willowherb and irises are establishing close to a headwall in the central part, south of the LEAP that will obstruct the system if not removed. Plants to be dug out.

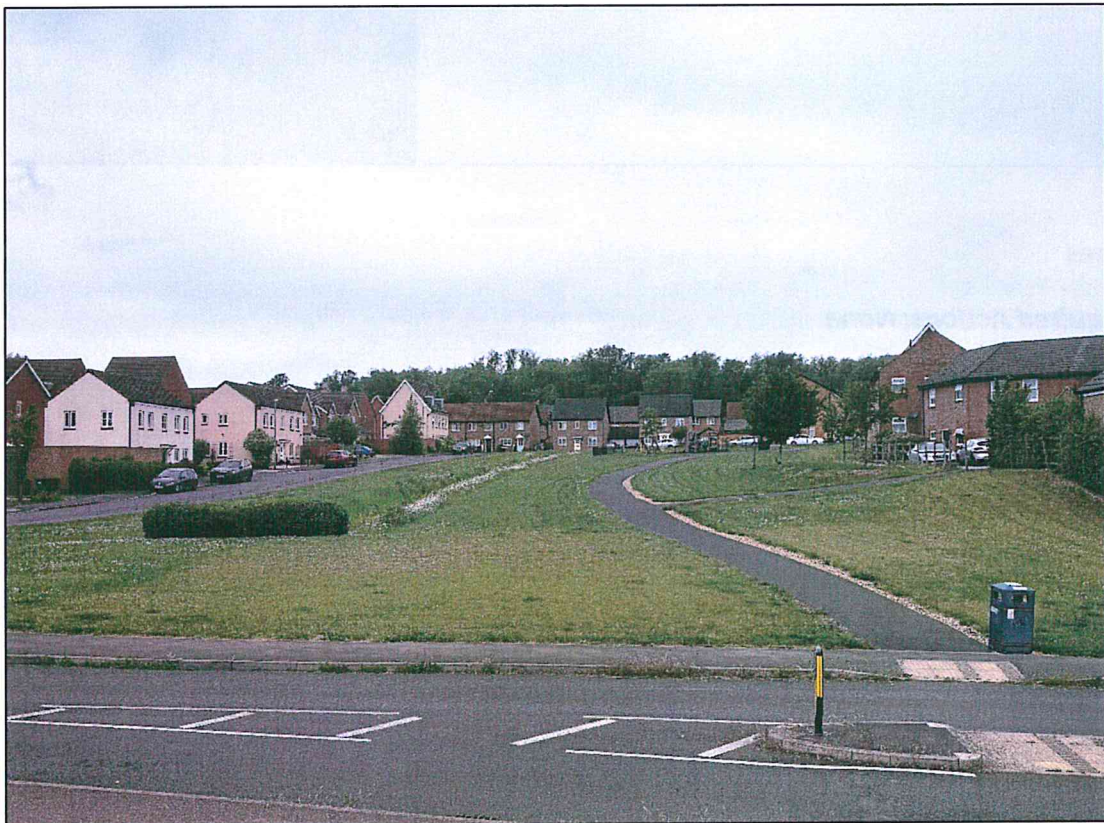
- 4.3 The southern part is more naturalistic in appearance and comprises a grassed mound with amenity trees in its northern half, and a vegetated swale and drainage basin with scattered native shrubs in its southern half.

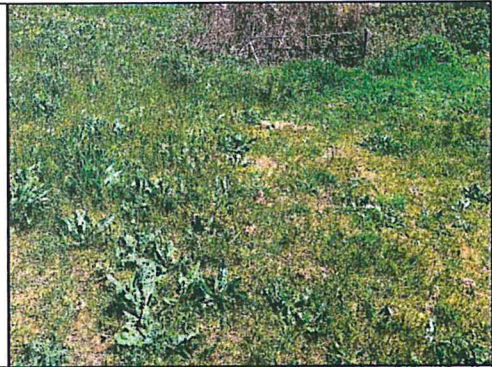
There are undesirable weeds in the southern grass area, such as bristly ox-tongue and creeping thistle. To be treated with spot spraying with a suitable herbicide to prevent spread.

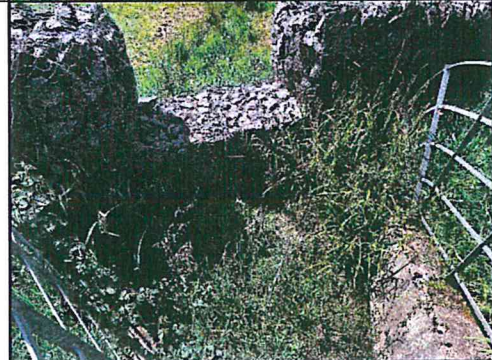
Sedge grass is growing close to the headwall in the southern area. To be removed to prevent seeding into the headwall area.

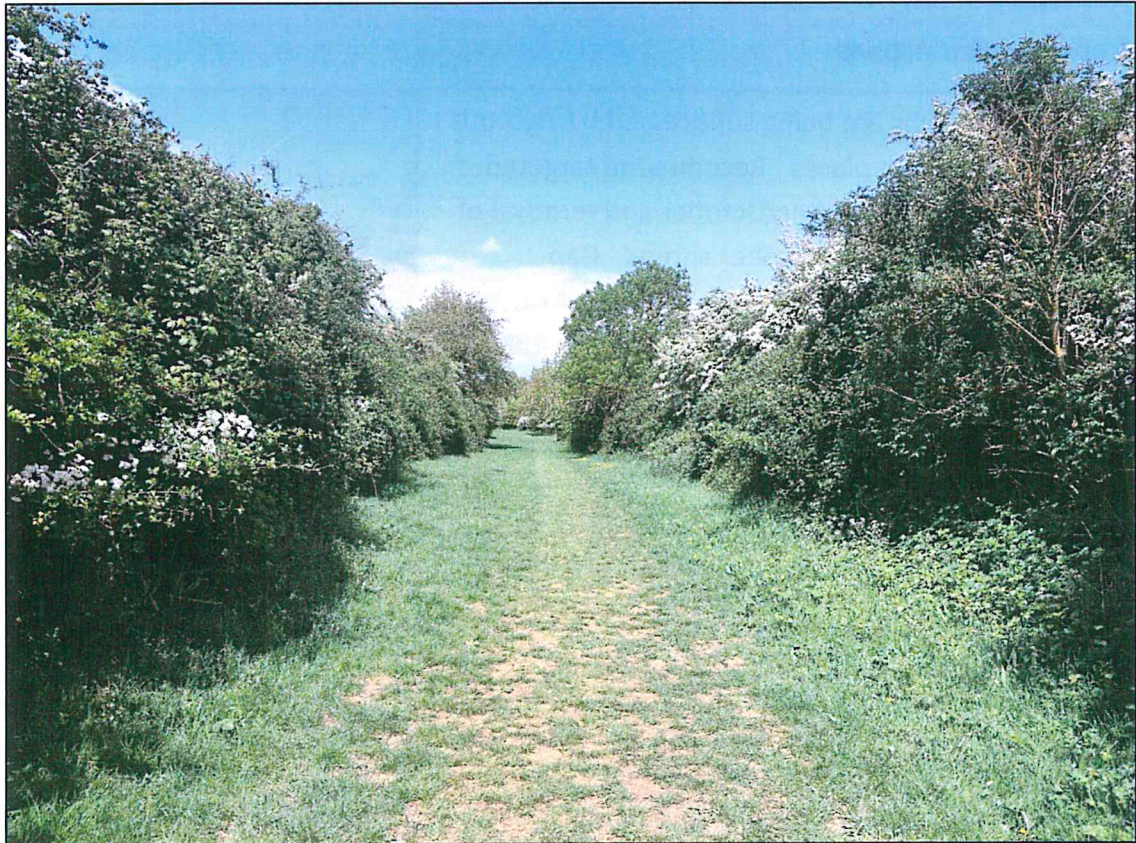
- 5.1 This is a linear corridor of meadow grassland flanked by native hedgerows, connecting Long Meadow with Long Croft Road. A desire line path runs along the centre of the space, with a timber gate providing access at the northern end. Several ash trees are located in the hedgerows that are suffering from ash dieback disease, with evidence of historic tree surgery.

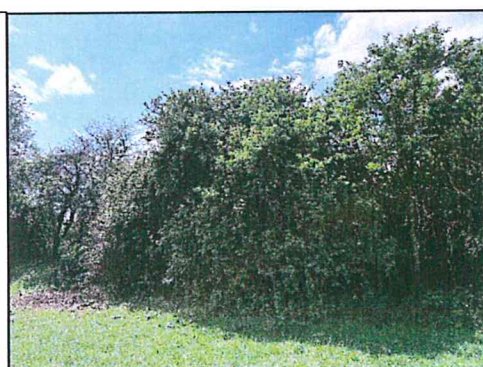
Hedgerow shrubs are being suppressed by vigorous bramble growth in places. Recommend targeted cutting back in September/October and removal of cut material to prevent further spread. Gap planting of hedgerows with native shrubs if existing shrubs do not recover.

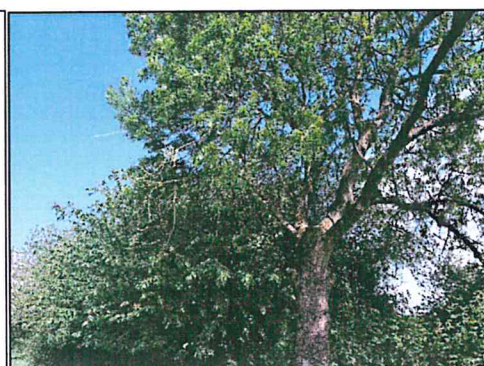
Ash trees within the hedgerows are suffering from mild to moderate ash dieback disease. Dead limbs to be removed as necessary to ensure public safety. Monitor and consider tree removal if dieback becomes severe.

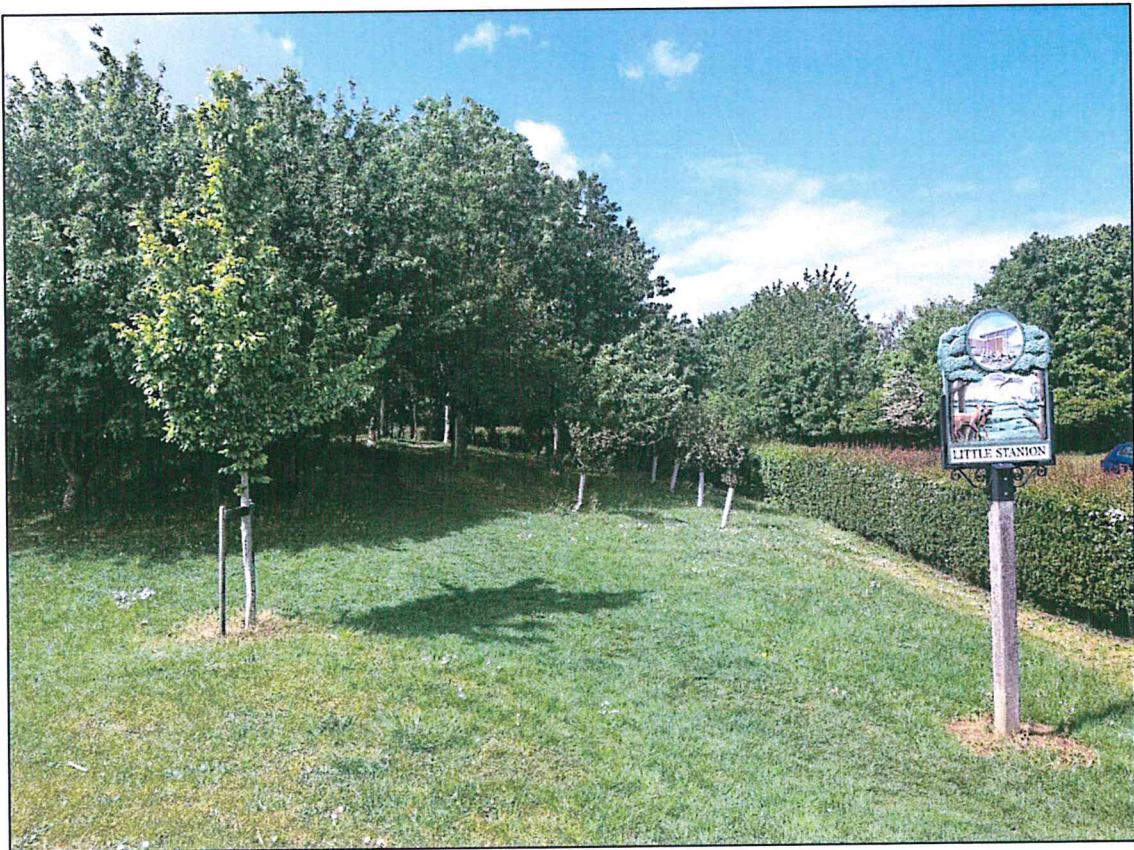
- 6.1 Linear bund following the boundary of the village with Long Croft Road to the north. The majority of the area supports semi-mature woodland approximately 15 years of age with an area of open grassland and amenity trees at its eastern end in which the village sign is located. An additional belt of grassland is located at its western end, between the woodland edge and the rear gardens of properties on Kesteven Way. A clipped native hedgerow forms the boundary between the woodland and highway. An unsurfaced path passes through the woodland, following the ridge of the bund.
- 6.2 Light thinning has commenced within the woodland, creating small canopy gaps.

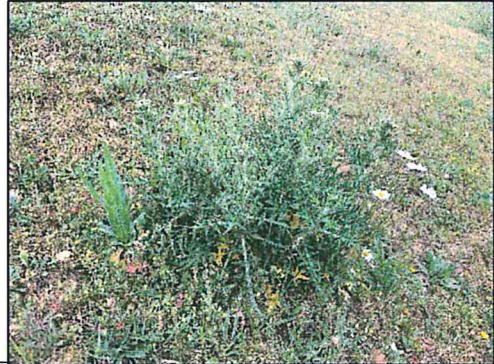
There are a number of spear thistle establishing in the eastern grassland area. Recommend they be treated with spot spraying with a suitable herbicide to prevent spread.

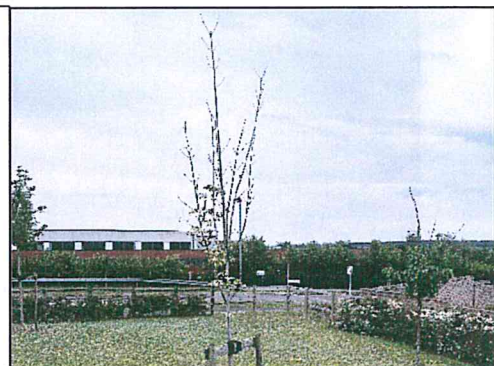
Health of cherry and Norway maple within eastern grassland area to be monitored as some trees are showing signs of decline. Trees to be replaced if decline continues. Progression of ash dieback within woodland to be monitored and deadwood removed if it becomes a hazard.

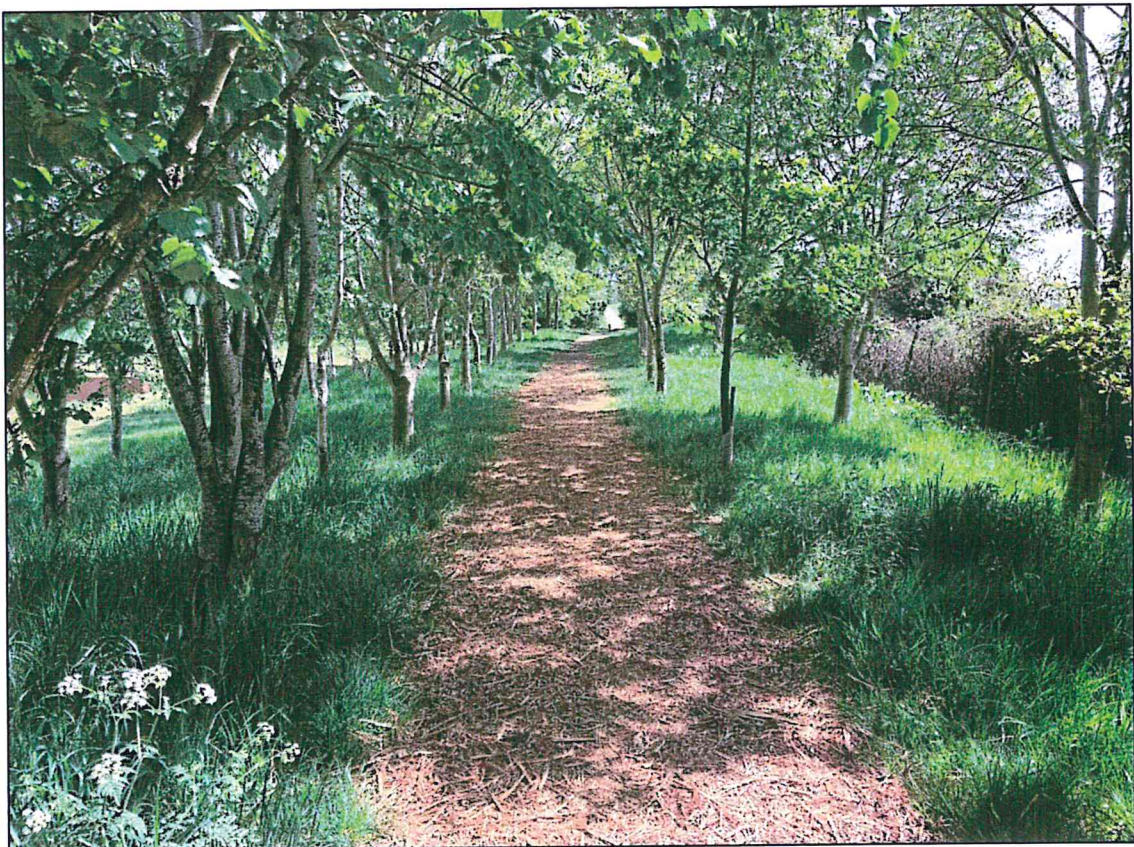
- 7.3 The woodland is generally in good condition and displaying vigorous growth and canopy closure. The ash trees are displaying symptoms of ash dieback disease and light selective thinning has been undertaken to remove individual trees displaying strong symptoms, with replacement trees of alternative species planted. Natural regeneration of ash, field maple and hawthorn is also occurring in canopy gaps, which will lead to a varied woodland structure in the future.

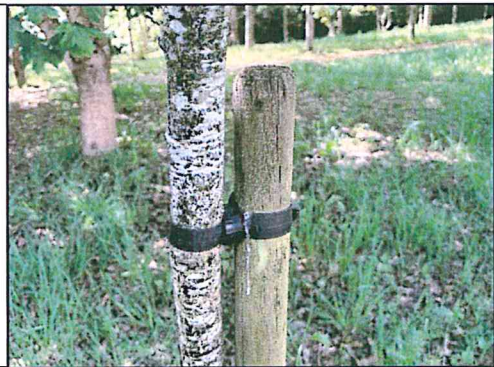
Tree ties on some of the replacement trees are beginning to restrict the trees. Ties to be loosened or removed if the trees are sufficiently self-supporting.

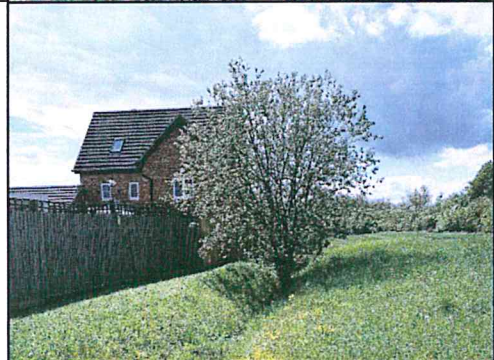
Goat willow trees are beginning to establish within the swale and will cause an obstruction if not removed. Trees to be cut and stumps treated with a suitable herbicide to prevent re-growth.

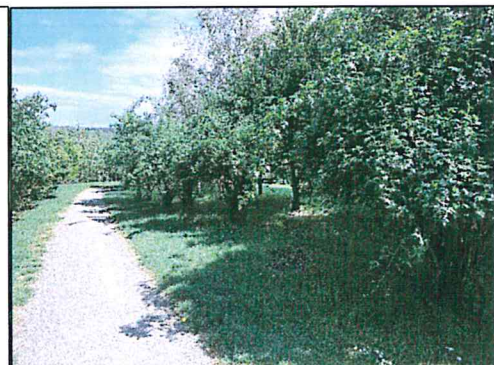
Dog rose shrubs at the edge of the path near to the undergrounding pylon are growing close to the path and could snag path users in future. Recommend they be coppiced and re-cut every 5 years to prevent encroachment.
