Open Space Condition Assessment

Little Stanion Farm Management Company

Little Stanion, Corby, Northamptonshire

Ref: 21/1422
Version: V2
Date: 17/12/2021

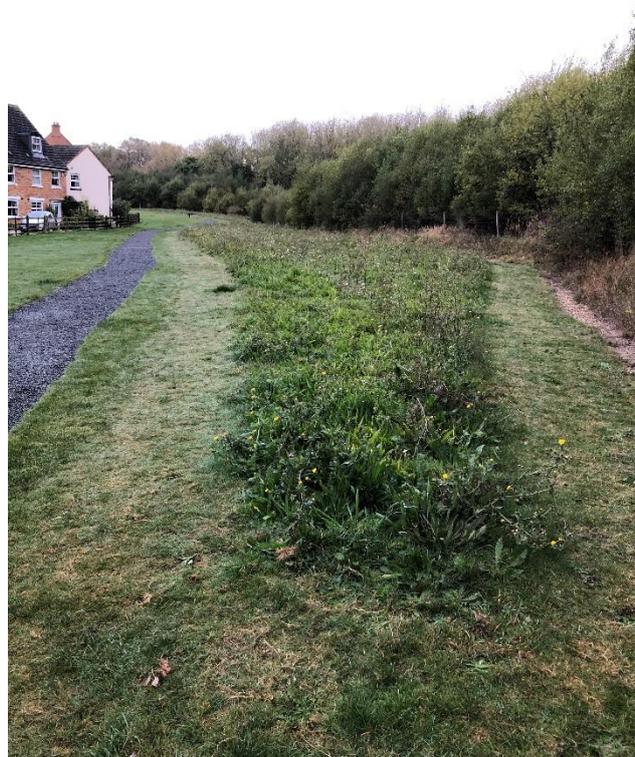
Area of Tree Planting

- 2.6. A number of supporting canes and spiral guards were either broken or missing. Some stock was found to have failed. Spirals were also seen that were choked with weeds and grass.
- 2.7. These trees were not part of the original landscape masterplan, rather were planted by a community group. Therefore, their maintenance and upkeep is not specifically the responsibility of the management company.
- 2.8. It is clear that if these trees do not receive the seasonal maintenance operations required, they are likely to fail in great numbers. Therefore, it is recommended that discussions are held to establish this management regime to ensure the longevity of this community asset.
